Peter Jenkins - B J Craft Anthem with TMCR, Part 8

Oops

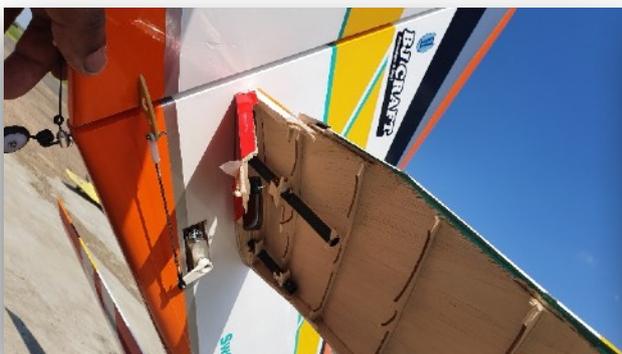
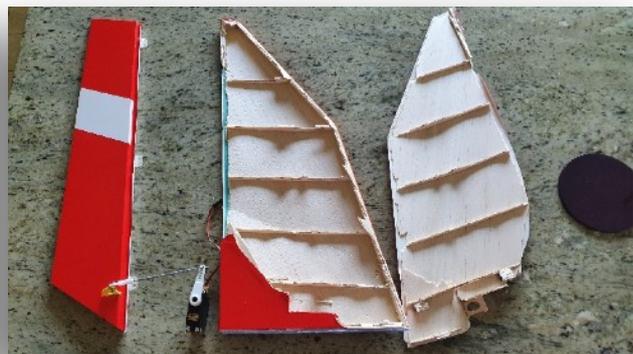
On reaching the aircraft, I saw that the starboard tailplane was still attached but when I got the aircraft back to the pits and looked underneath, there was no bottom sheeting there. The elevator and the servo and push rod were also missing. See photos below.

After communication with B J Park, the Anthem designer, he put the finger on the JR 3301 servos I'd used for the elevators. In his view, the plastic gears were on the weak side and putting a long servo arm onto this servo was the most likely cause of the gears stripping. Now, I've used plastic geared JR and Futaba mini servos for elevators for a long time and I had never heard that the 3301 was considered to have a weak gear train. However, there was no disputing the fact that both elevator servos had stripped their gears.

Assuming that the starboard elevator servo gear train failed just after I pulled up into the 45 deg climb, this would have allowed the elevator to flap away and lead to flutter inducing force on the starboard tailplane. Flutter is usually denoted by a buzzing noise and I never heard this but then again, the aircraft was about 200m away from me. Flutter is exceptionally destructive over a very short period of time. This would have accounted for the structural destruction of the starboard tail plane which had the bottom section ripped off and the elevator, with servo still attached, went with it. I had put a servo lock on the elevator lead and that was still attached to the socket in the fuselage! Perhaps it was a good thing the elevator lead managed to break free avoiding having the servo and elevator flapping around interfering with the rudder.

I felt it prudent to replace both tail planes since I had no idea what the port tail plane had been subjected to. The other piece of damage was to the starboard u/c leg that got stuck in a hole in the rough grass and damaged the section bolted to the u/c plate. The fuselage also showed signs of a crack running aft from the join between the u/c box and the fuselage side. A short while later when re-checking the aileron throws, I found that both aileron servos, Futaba BLS153s, developed a jitter when I placed the control surface throw measuring device on the aileron. The BLS 153 has plastic gears yet has never given me any problems in other installations. Since the jitter disappeared as soon as I moved the aileron stick I decided that the shock of the flutter failure may have damaged the 153 gear trains and since the ailerons were at neutral at the time of the flutter incident the damage would have been to those gears in contact at that position. Thankfully, they were not so damaged as to cause a problem with control but I was not prepared to use them unless I could replace the gear train. Guess what – no supply of gears! So, 2 new aileron servos were needed as well.

In the end, I've ended up with all MKS servos as follows: Ailerons – HV 737; Elevators HV 69, Rudder HV 747 (originally fitted). I also replaced the aileron and rudder control rods with Secraft 3mm turnbuckles and 3mm ball links. I had carefully examined the elevator pushrods and they were sound so I re-used them.
