SIG Rascal 110" renovation, 6

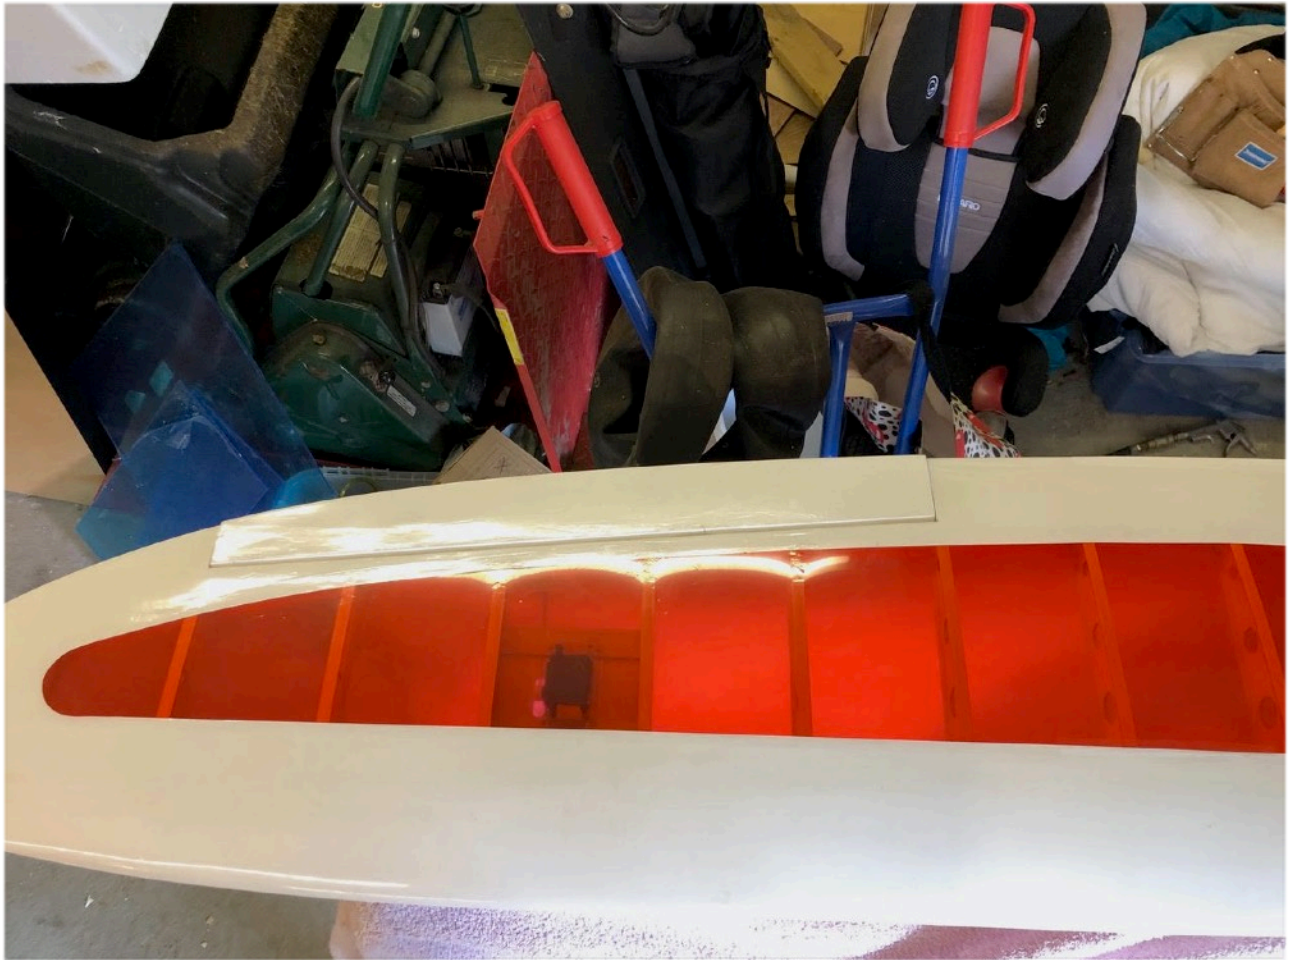
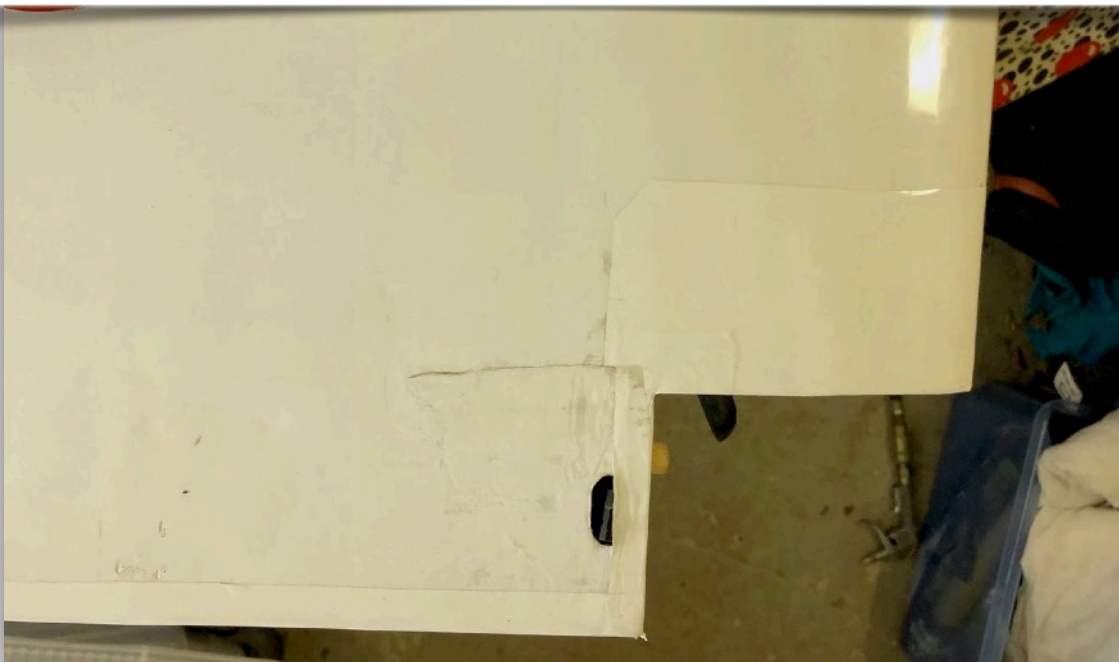
At first look, the wings look to be in fairly good condition albeit the red panels are a bit faded. However it is obvious that, over the years, repairs have been made.

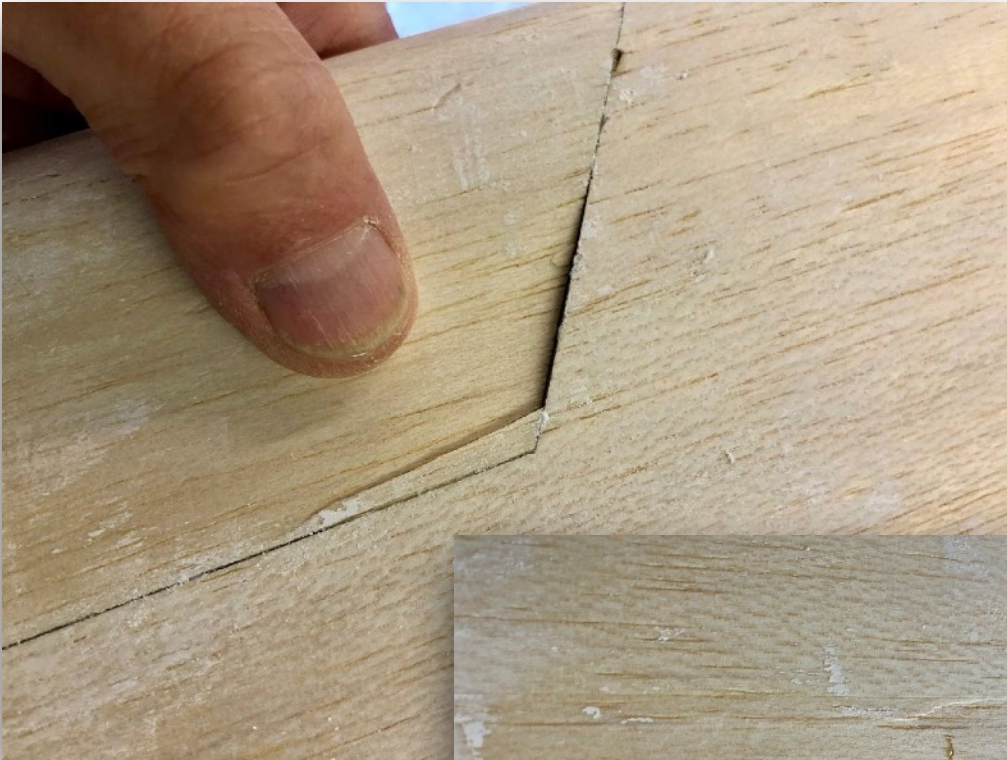
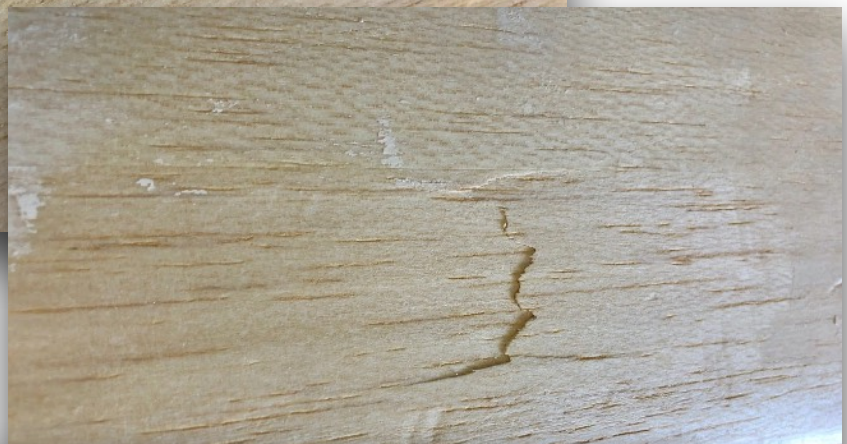
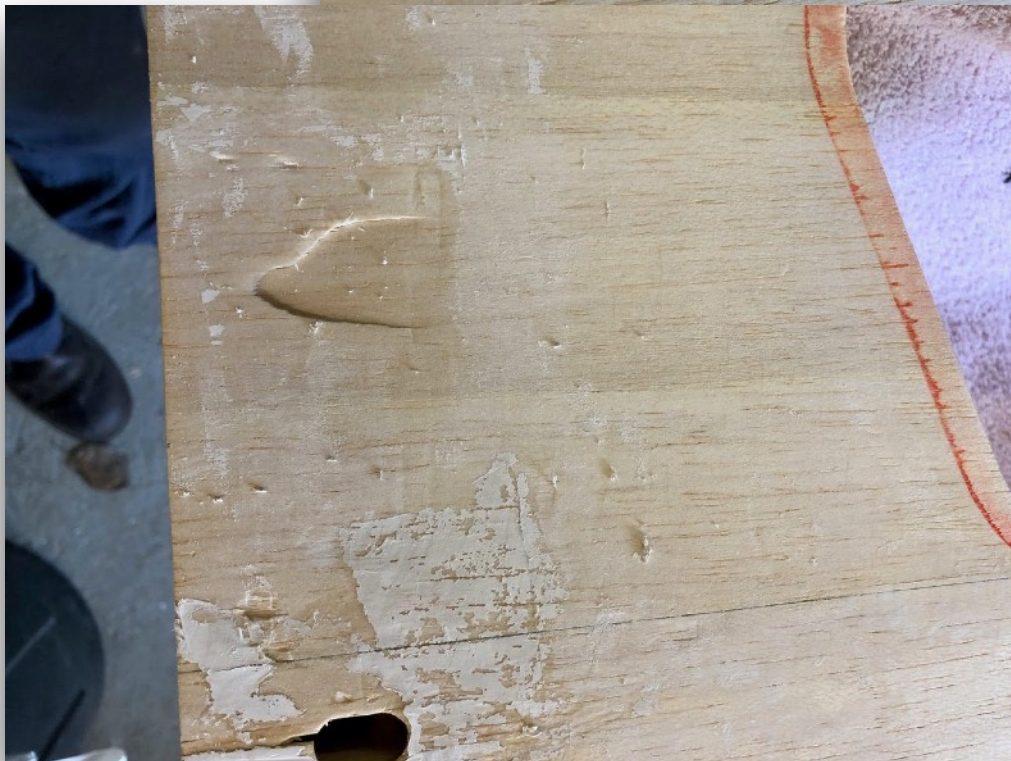
Stripping back the covering on the starboard section revealed a few areas of slight damage, mainly, I would guess, due to rough handling.

Nothing major so I continued to clean up the frame using my small Hobby King heat gun and scraper.

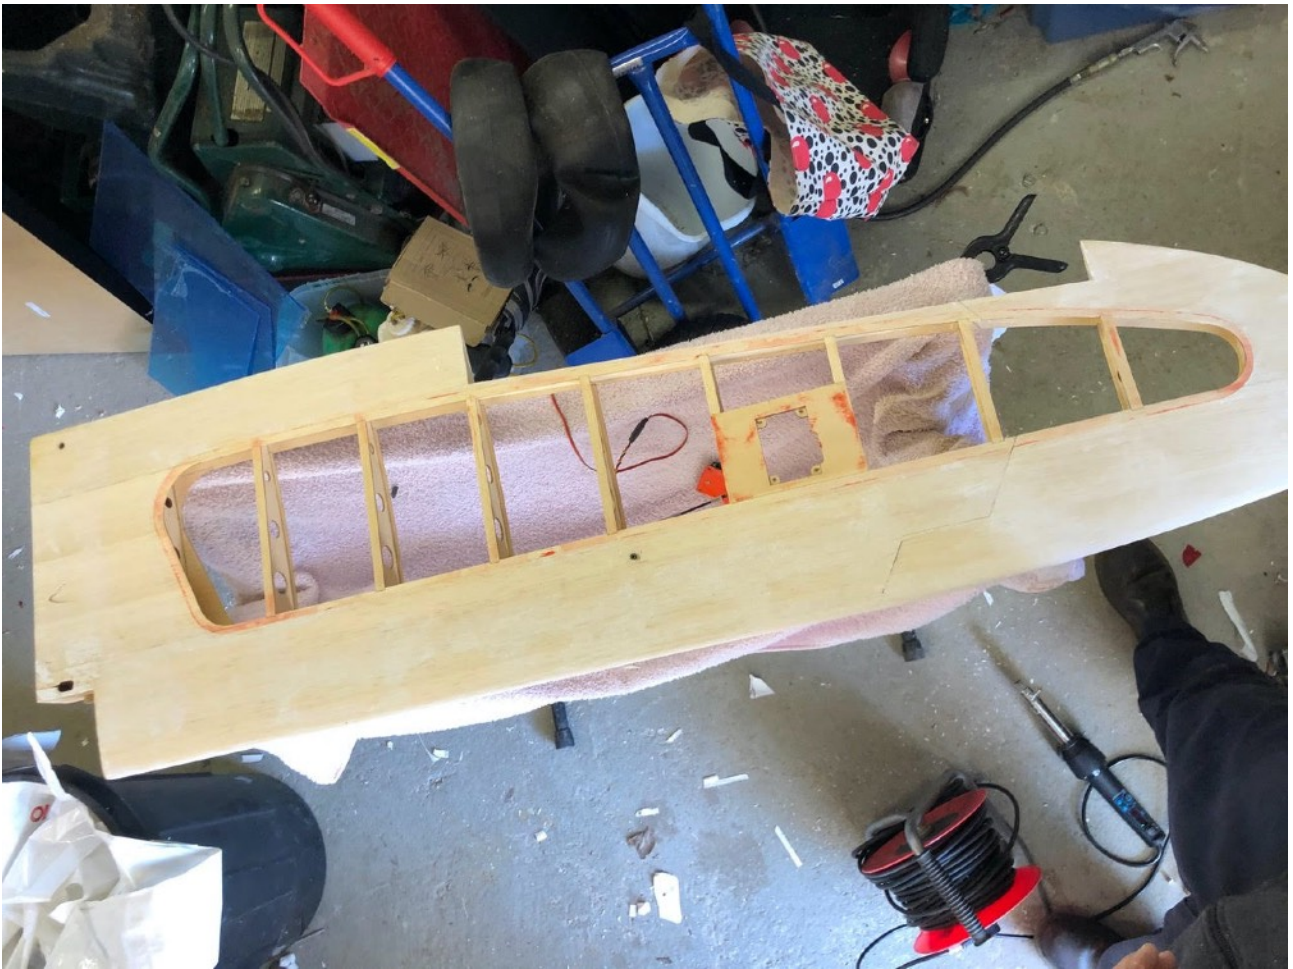
The advantage of this tool is that it is a lot more controllable and less fierce than the large heat gun I used on the fuse.

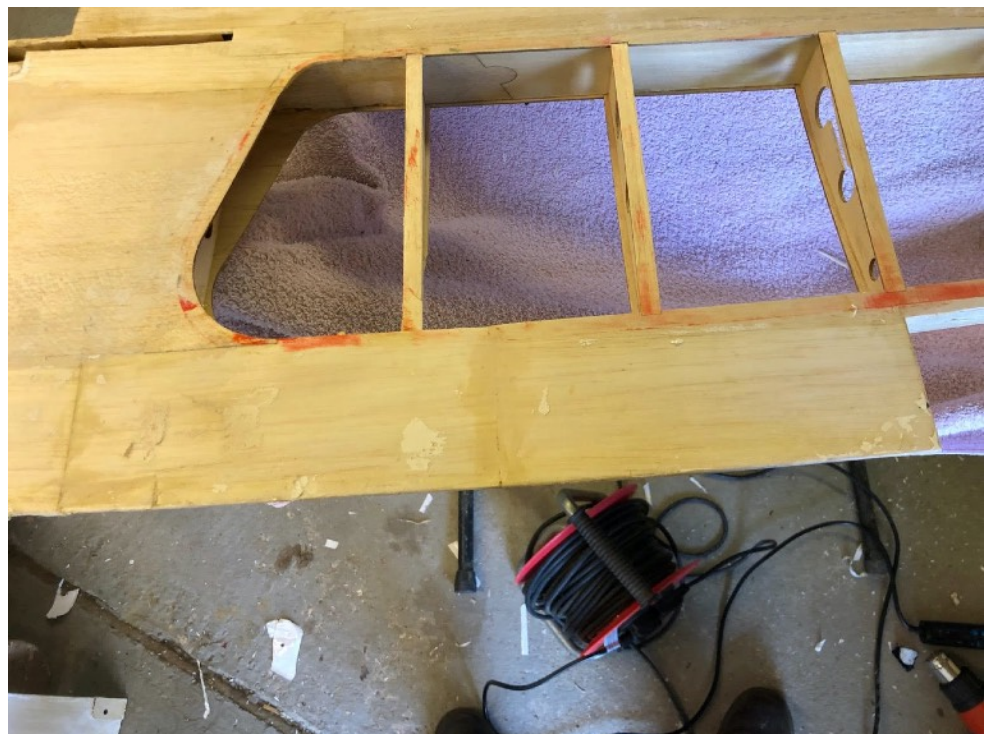
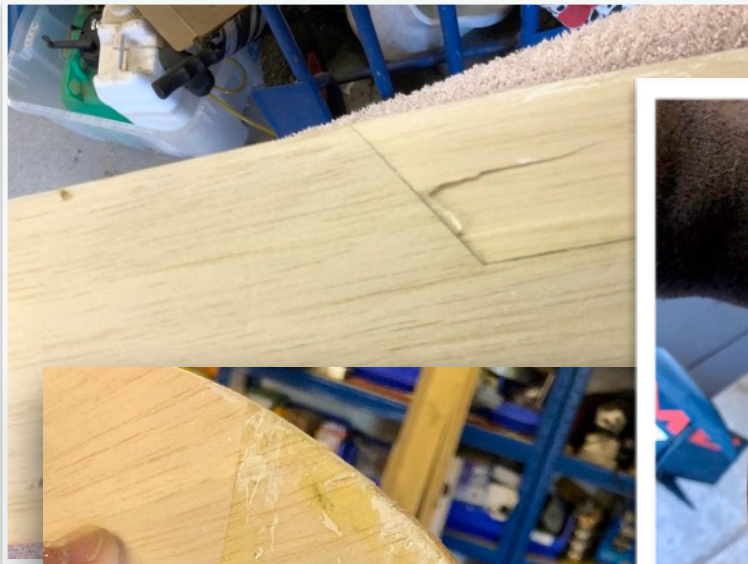
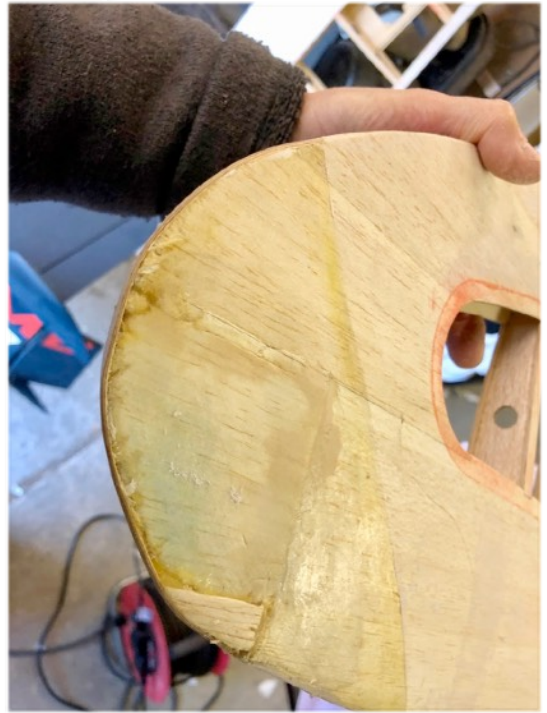
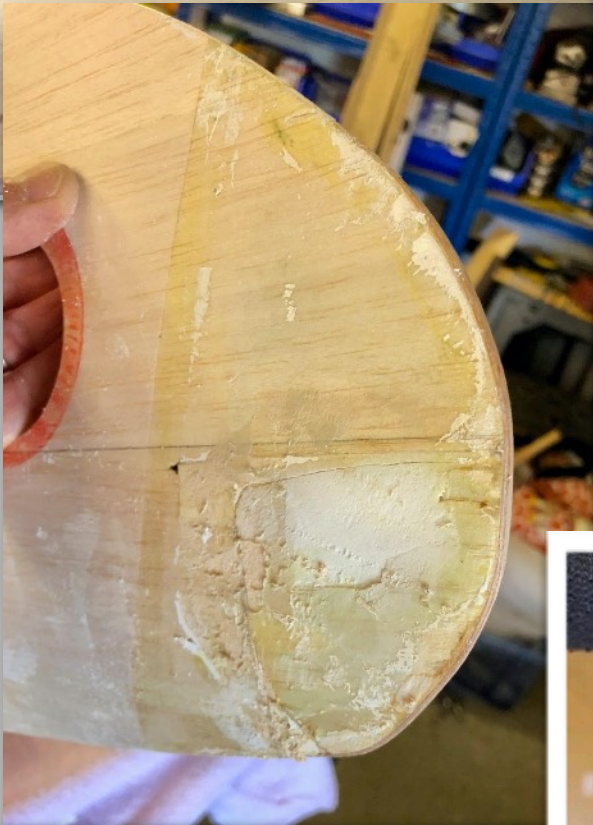
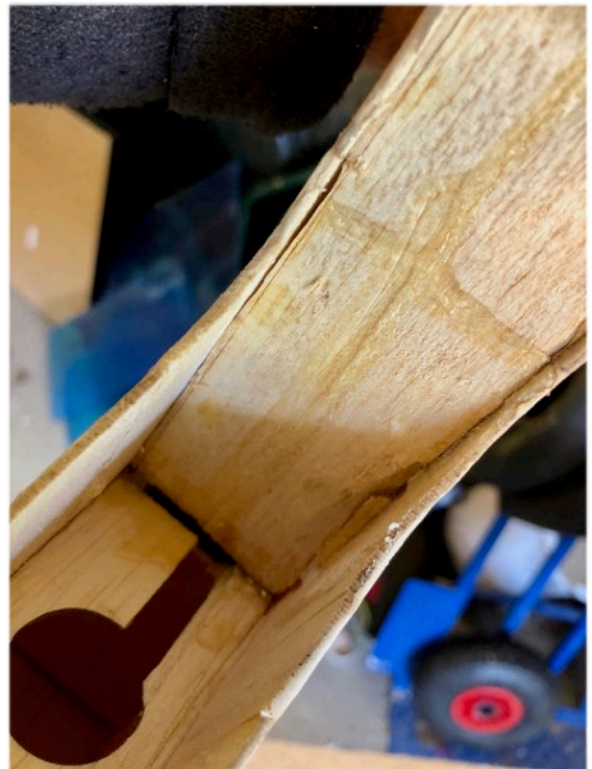
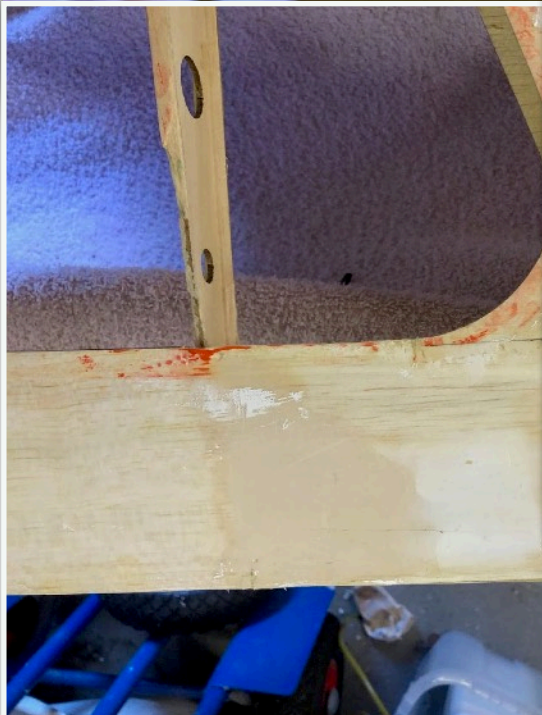
Next I carried out the same on the port wing but ended up in a much different situation! It is obvious that the Rascal had quite a severe crash at some point in its history, one that, by the looks of it, broke the wing in half just outboard from the root. I suspect that it came in hard onto the wing tip (also damaged) and this caused the wing to shear and was also the cause of the damage to the fuse, just above the windscreen. The following pictures tell the story.

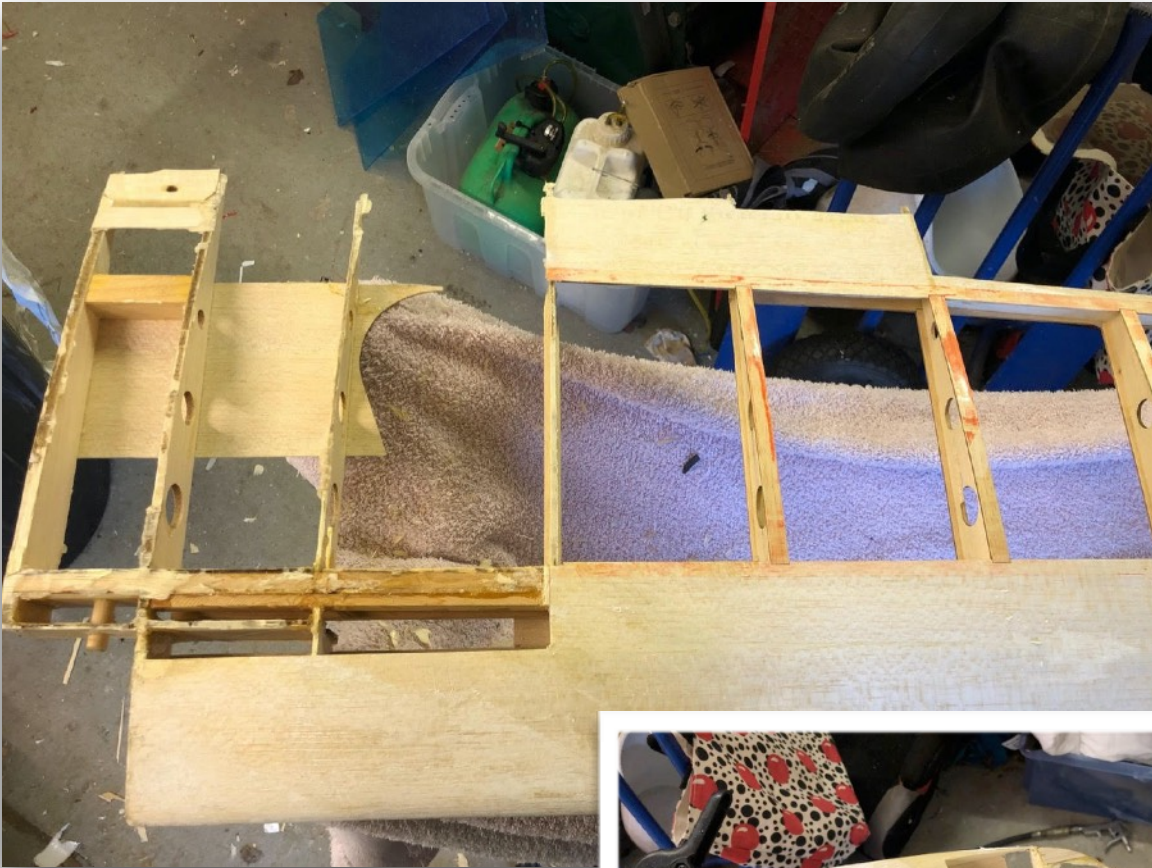
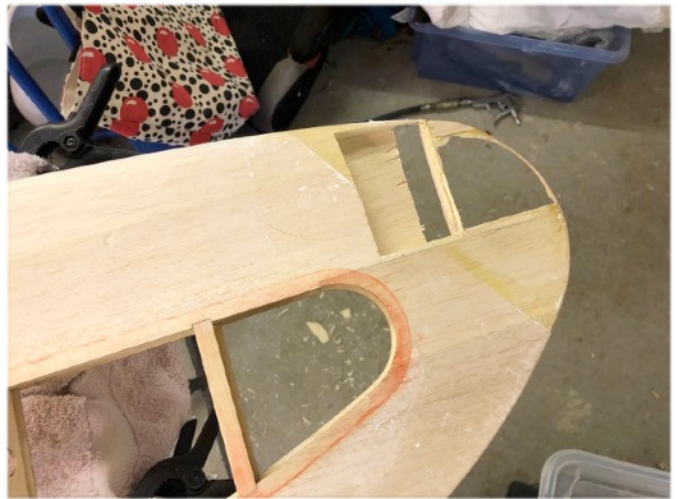
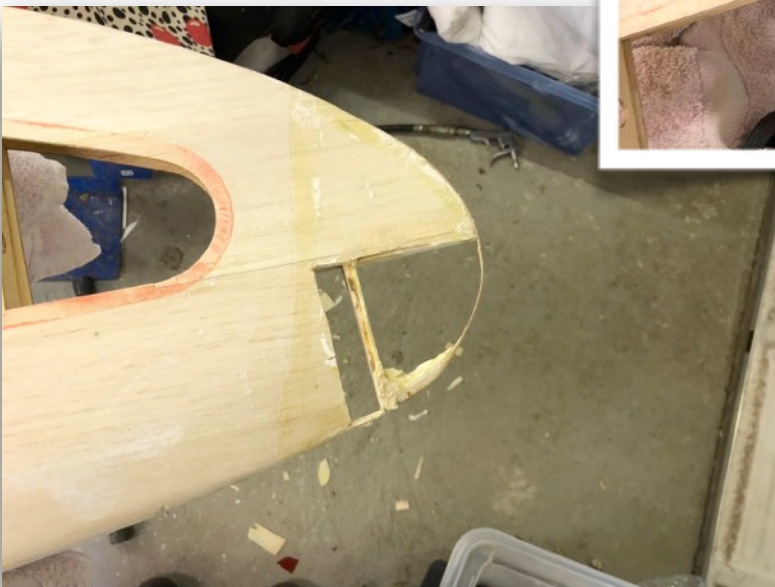
Having removed the covering I then set about cutting out the repair balsa mainly so that I could see 'underneath the skin' to see the exact extent of the damage and the repairs. I ended up with this.

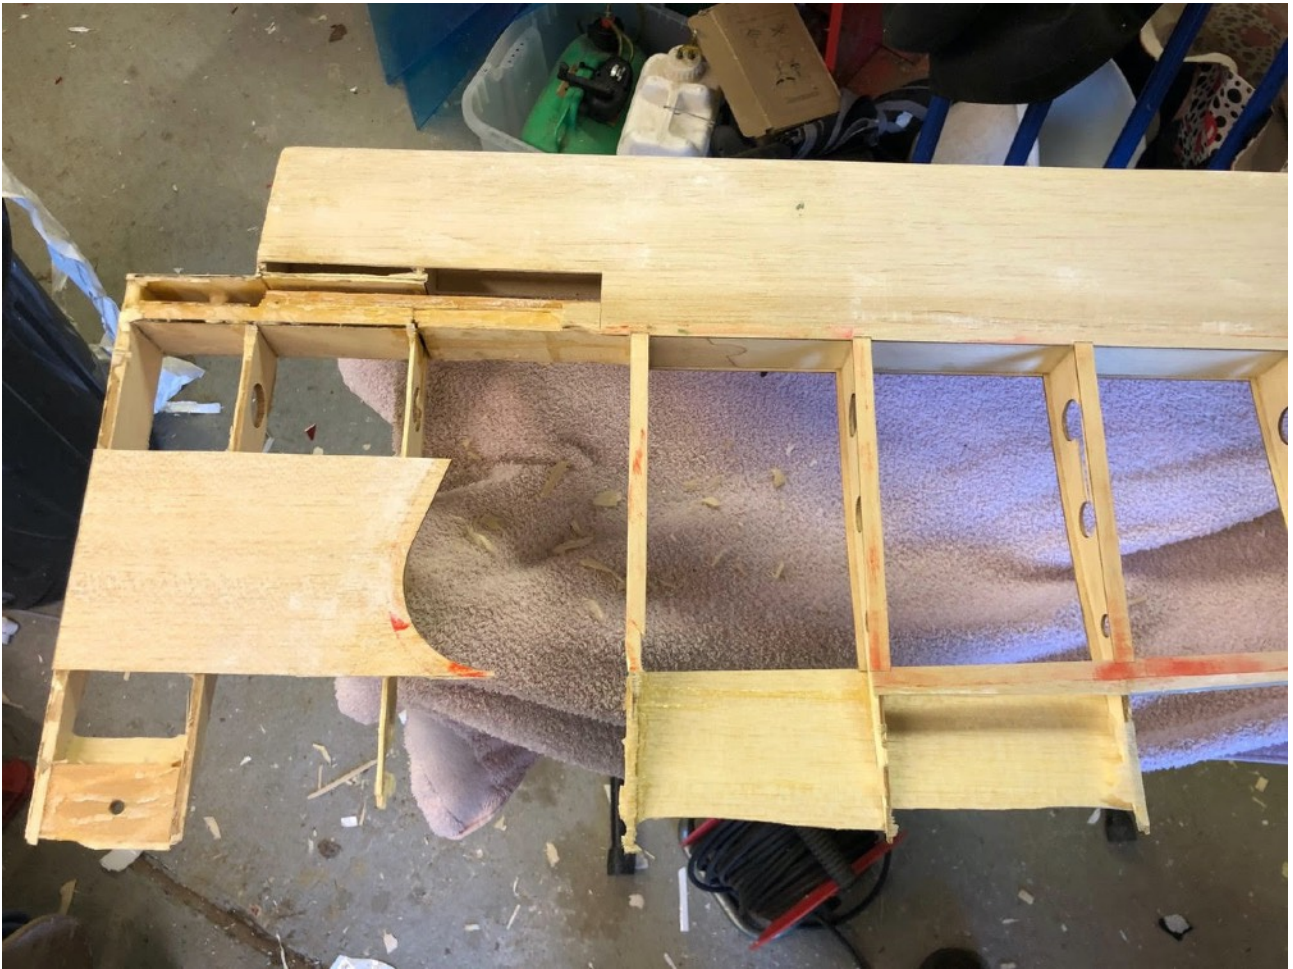
You can see that the TE section, inboard of the aileron has mostly been cut away.

As I have to carry out fairly extensive repairs in this area I have decided to convert the wings to have flaps. Later Rascals are now supplied with flaps so it's more of an upgrade really! I now need to order some more balsa from SLEC as I haven't got any of the correct thickness of the correct grade (hard).
