Ron Gray, Lavochkin LA-7

Resurrection, 10

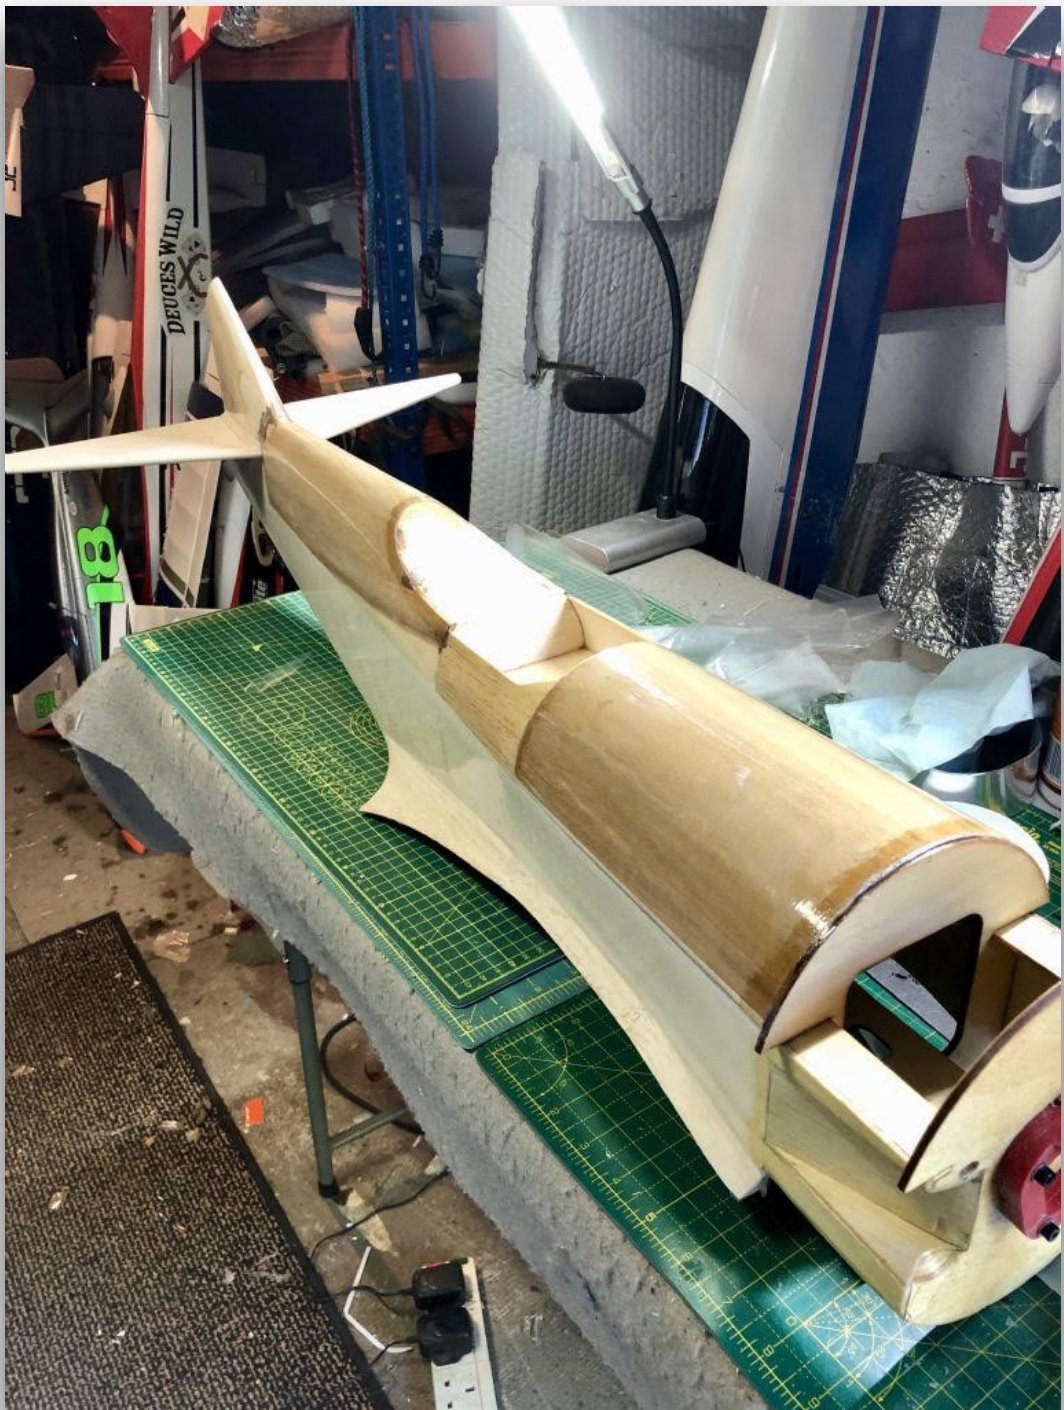
The fuse got covered in laminating film, the most difficult bits being the concave curves on the wing fillets. I tackled these by using a separate strip of film, just wide enough to span the fillets then I tacked them in place on the fuse sides.

To get the laminating film stuck into the concave curve I used a couple of different diameter tubes, one copper one alloy, heating them up in the hot air gun then rubbing them onto the film.

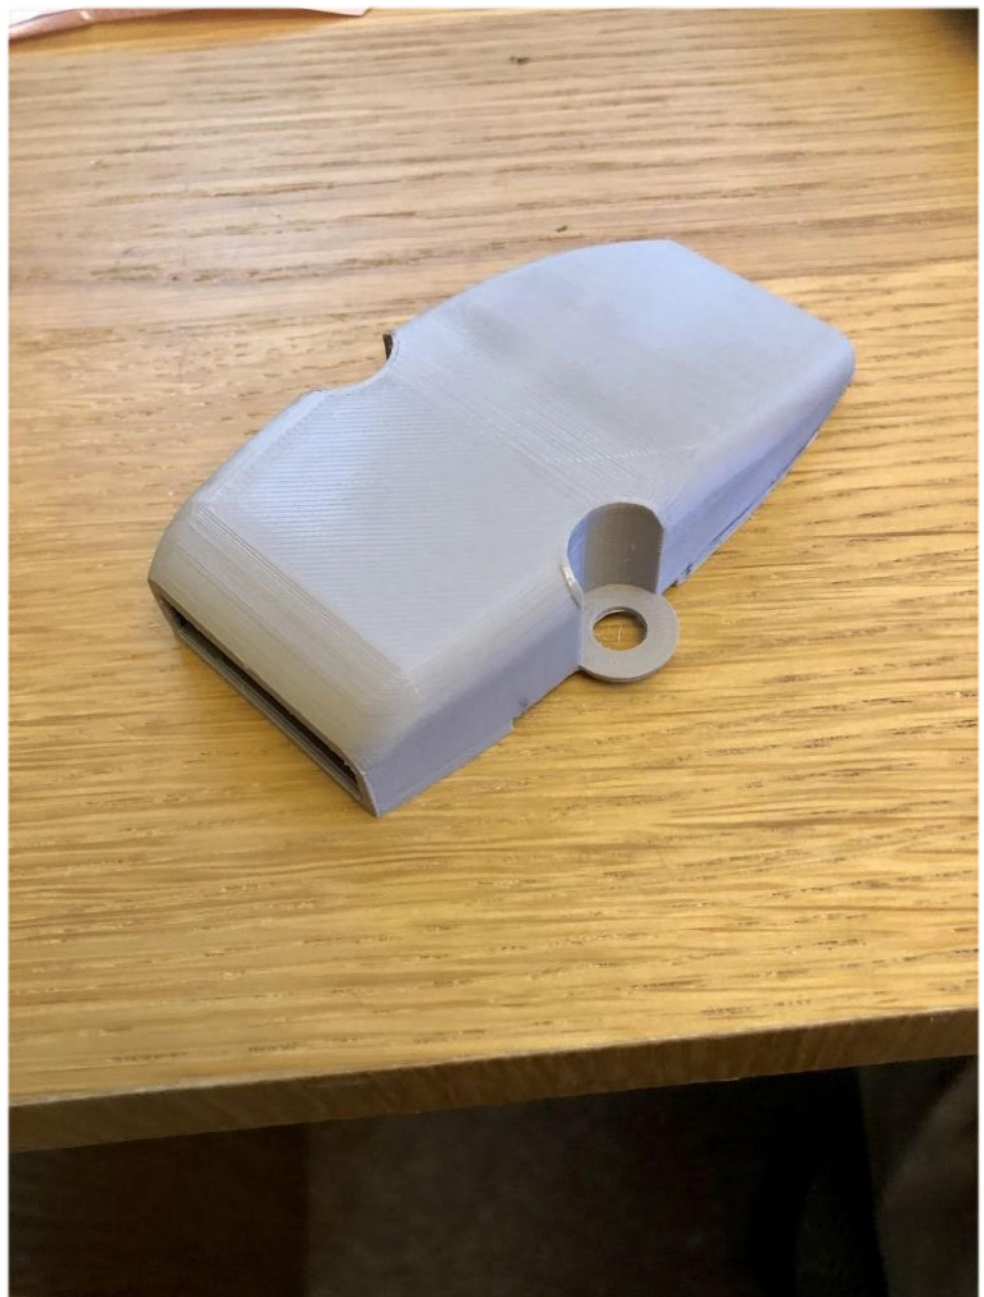
I decided that the under belly radiator / air intake as shown on the plans and the moulded mouth piece provided were a little on the large side so over to the 3D printer. The advantage of doing it this way was that I could incorporate the wing fixing bolts which otherwise would have got in the way.

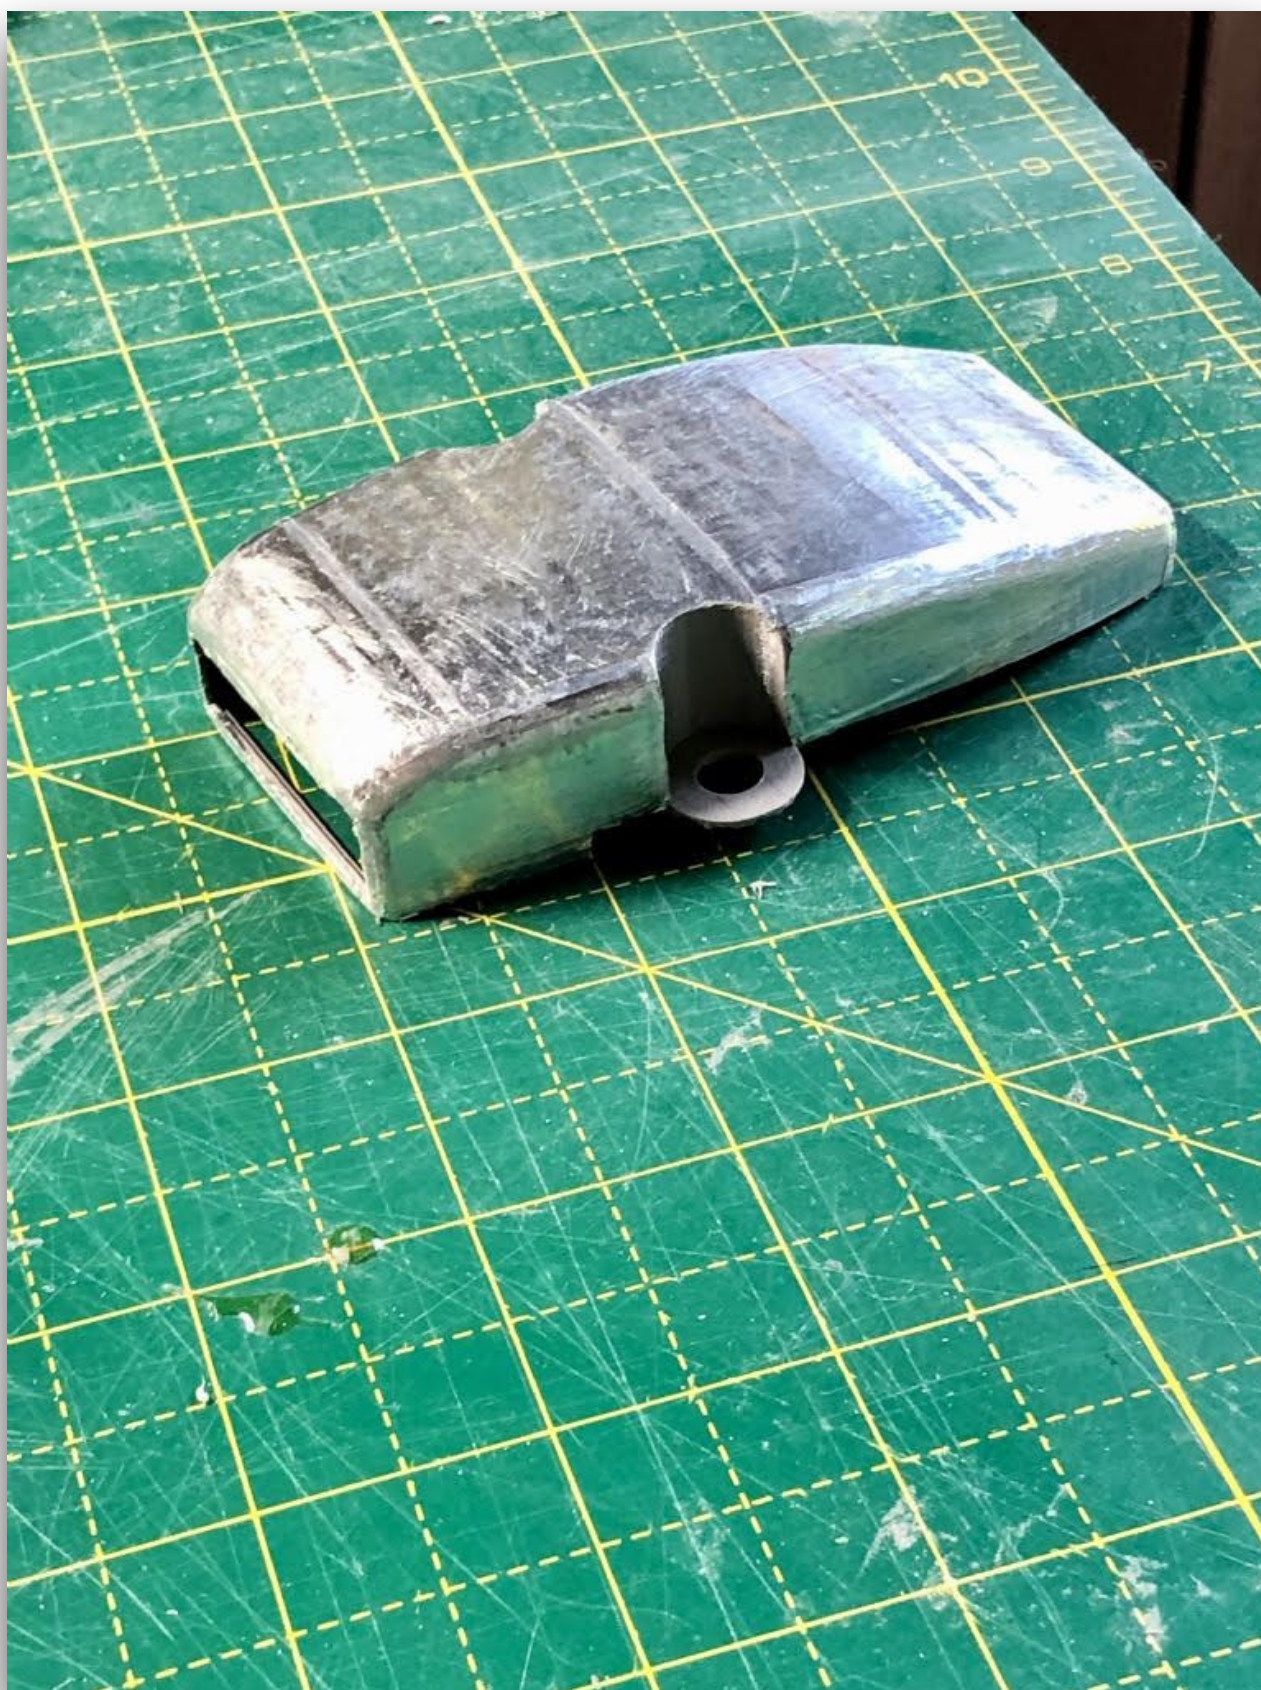
Then covered with aluminium tape (will be primed and painted).

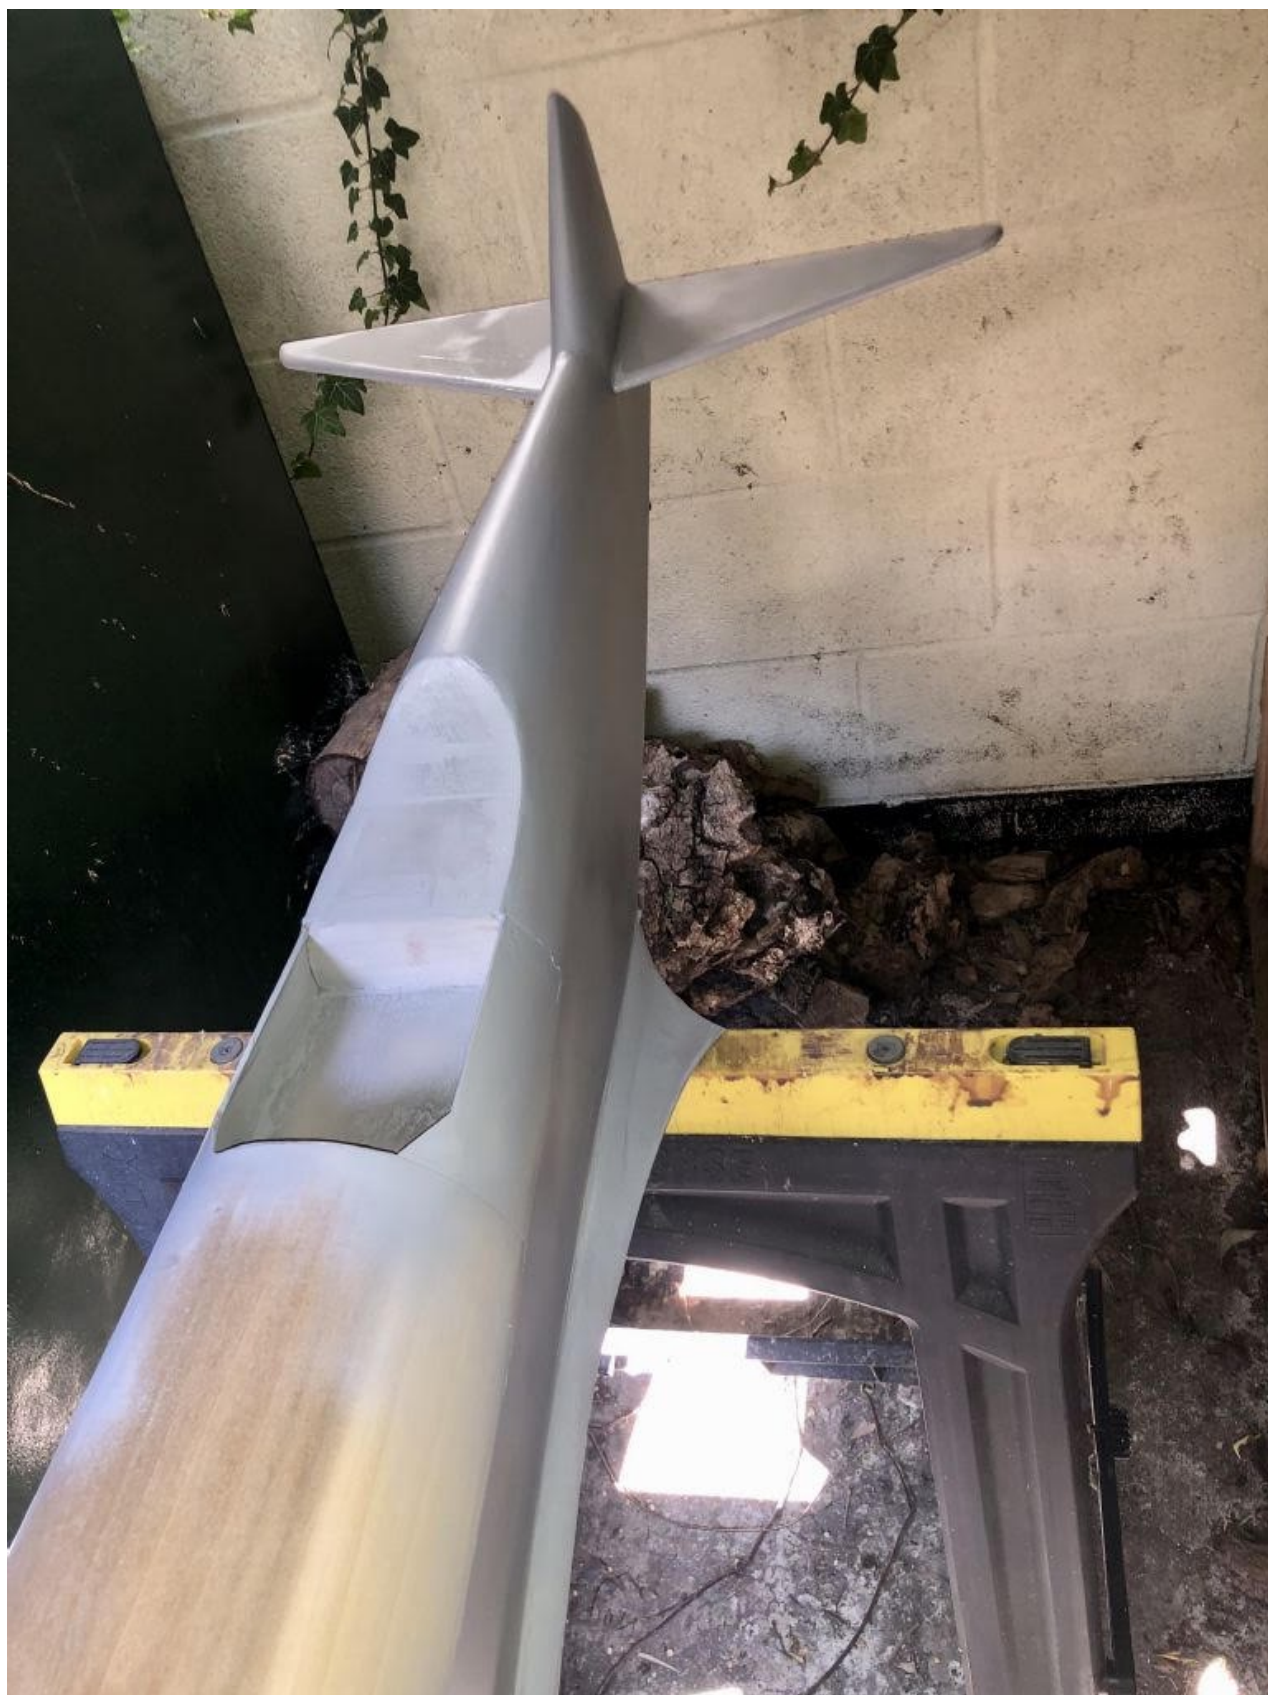
Following on from the aluminium tape applied to the wings to simulate the access panels, I did the same thing for the fuse, before starting the priming work.

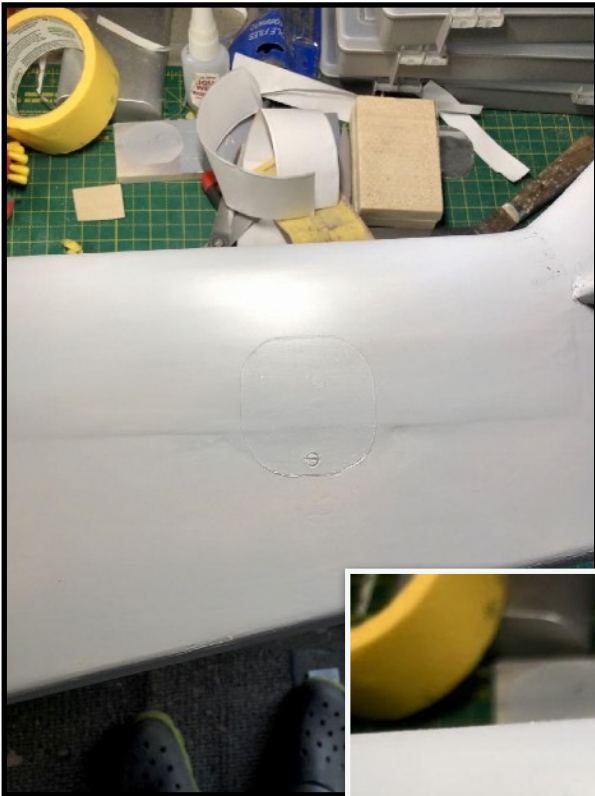
A close look at the
fuse service panel.

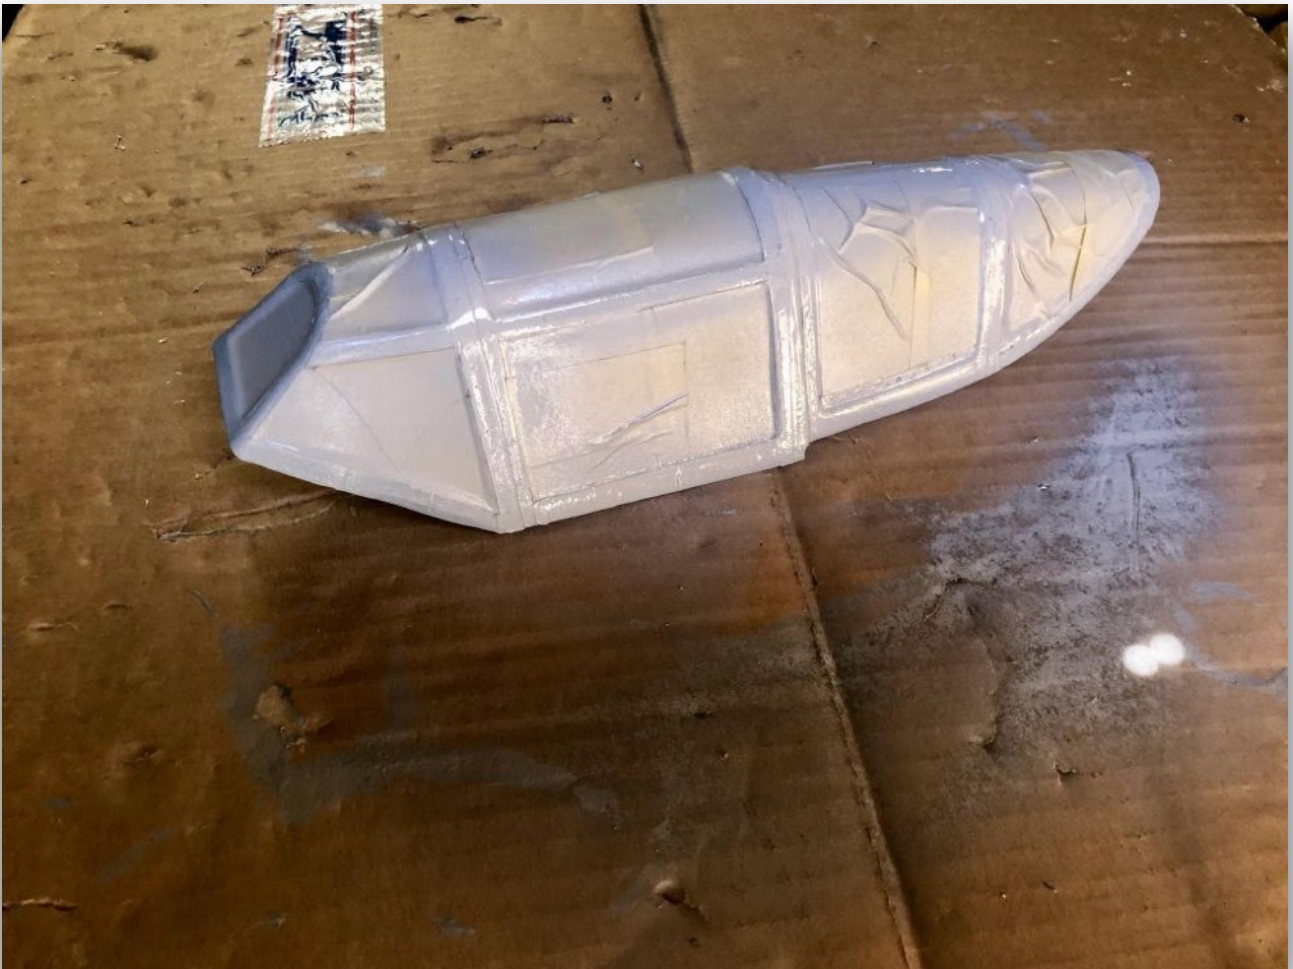
I then spent many, many minutes masking the canopy and then priming it.

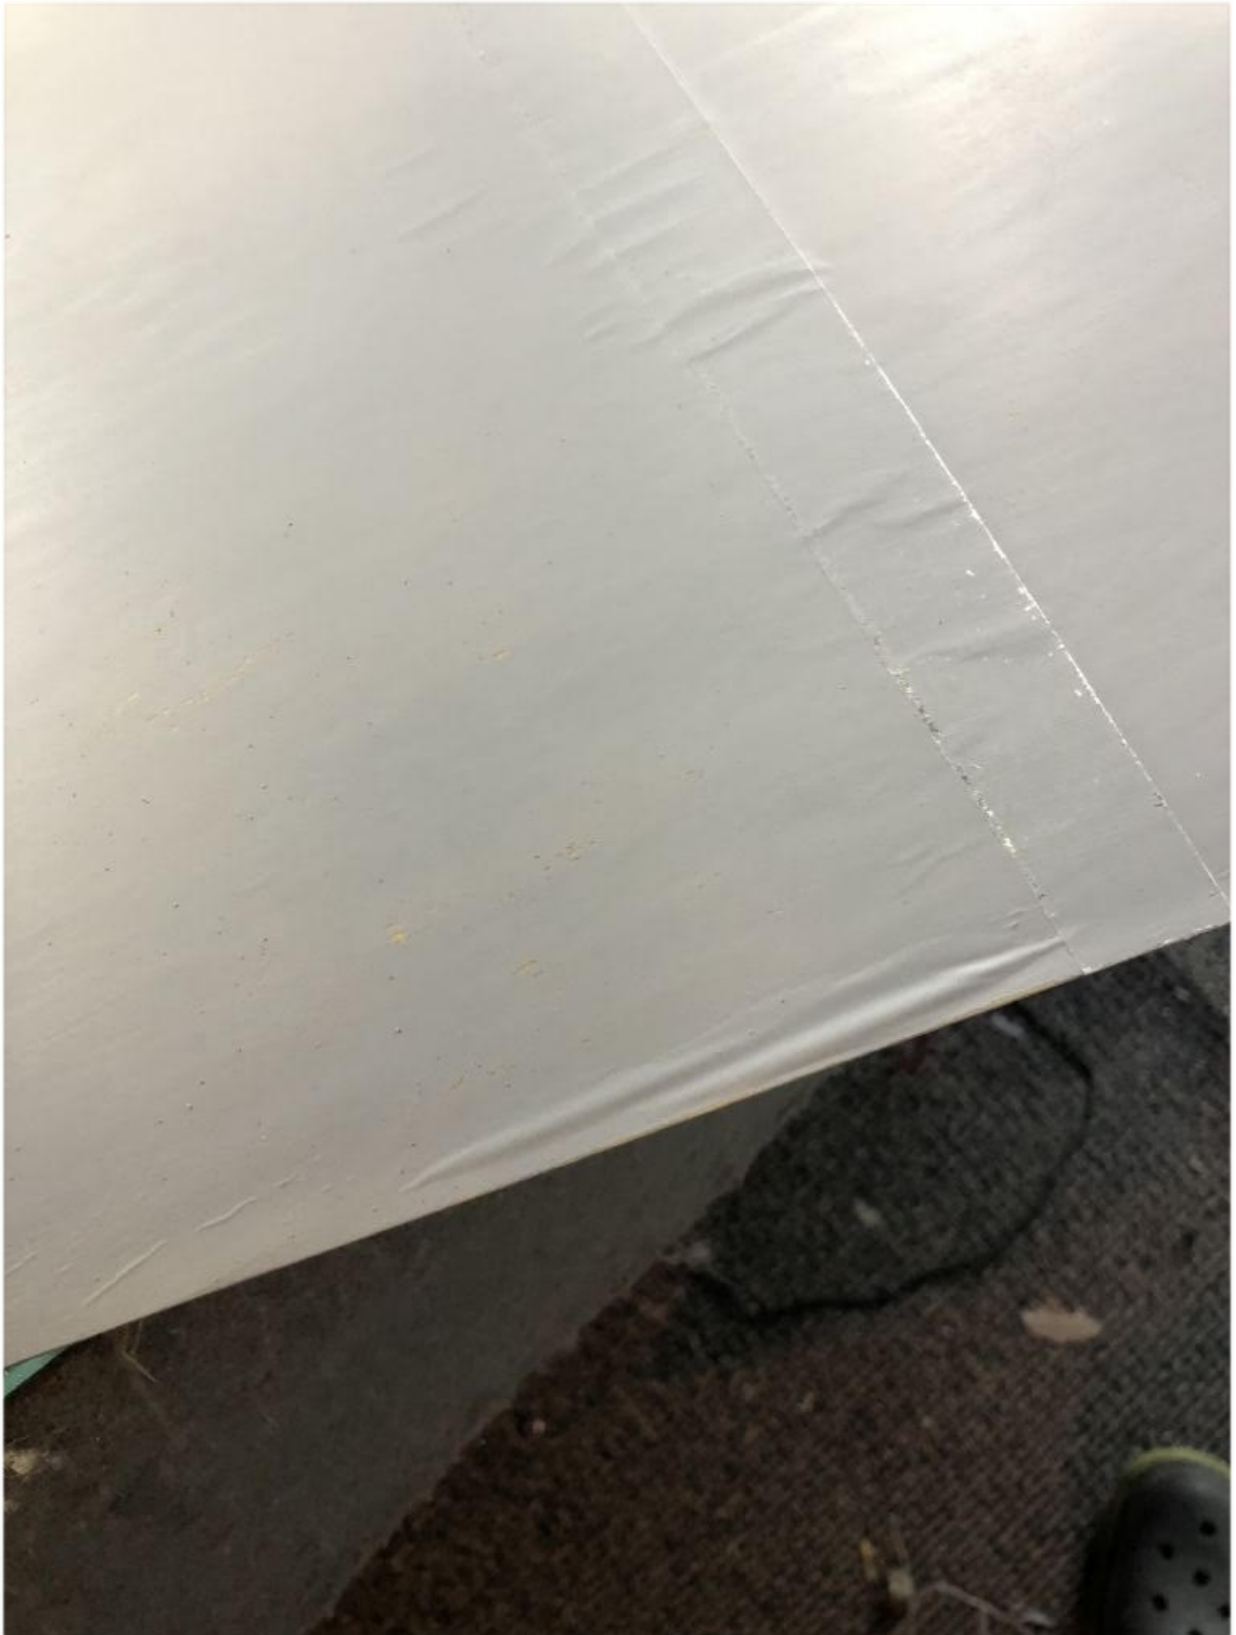
The problem I now have is that the finish is too good! Now that I have rubbed down the primer the surface is silky smooth so I've got to think of a way to 'distress' it a bit, to make it look 'tired' and like it has been in many battles.

The primer has also helped me locate areas where the laminating film was not fully shrunk / ironed down. Whilst I really do like using the laminating film, being clear and very glossy it is sometimes difficult to see wrinkles, but the primer makes them stick out! Fortunately there were very few and were easily got rid of with the sealing iron.
