YT (ESM) Hurricane Refurb, Part 3

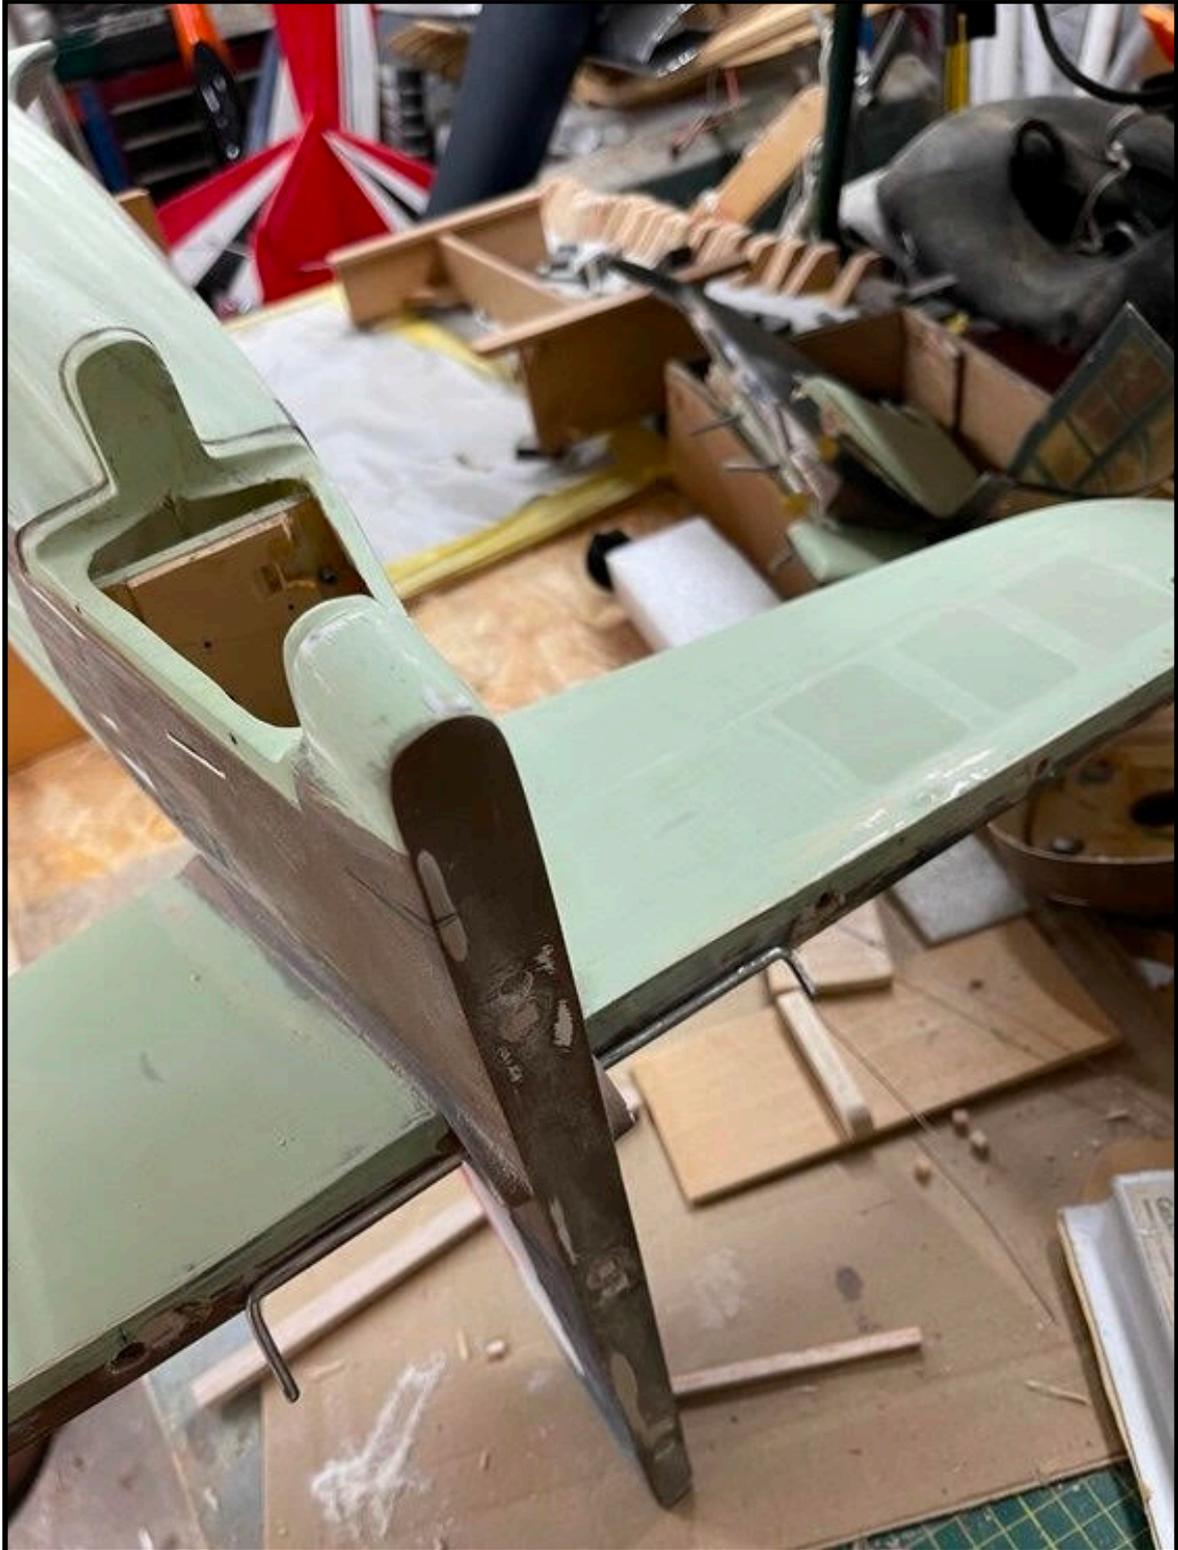
As with the elevators, due to the poorly fitted hinges on the rudder I cut them off in readiness for new ones. In the end I decided to fit inboard controls for the elevators controlled by a pull pull system.

New elevator joiner with silver soldered control horn.

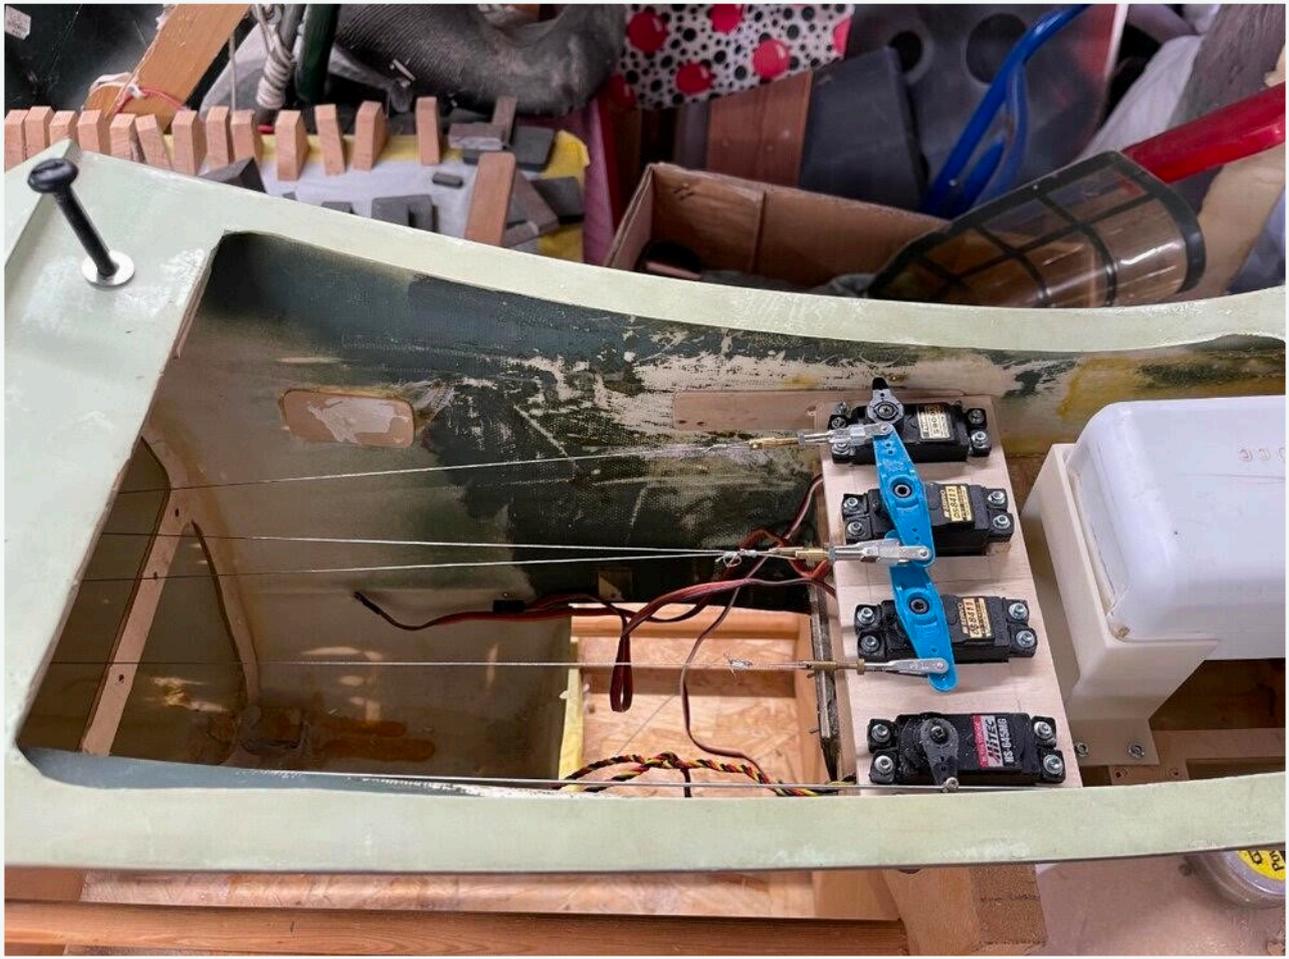
A new, raised servo tray had to be installed and the servos, together with pull pull for both rudder and elevators fitted.

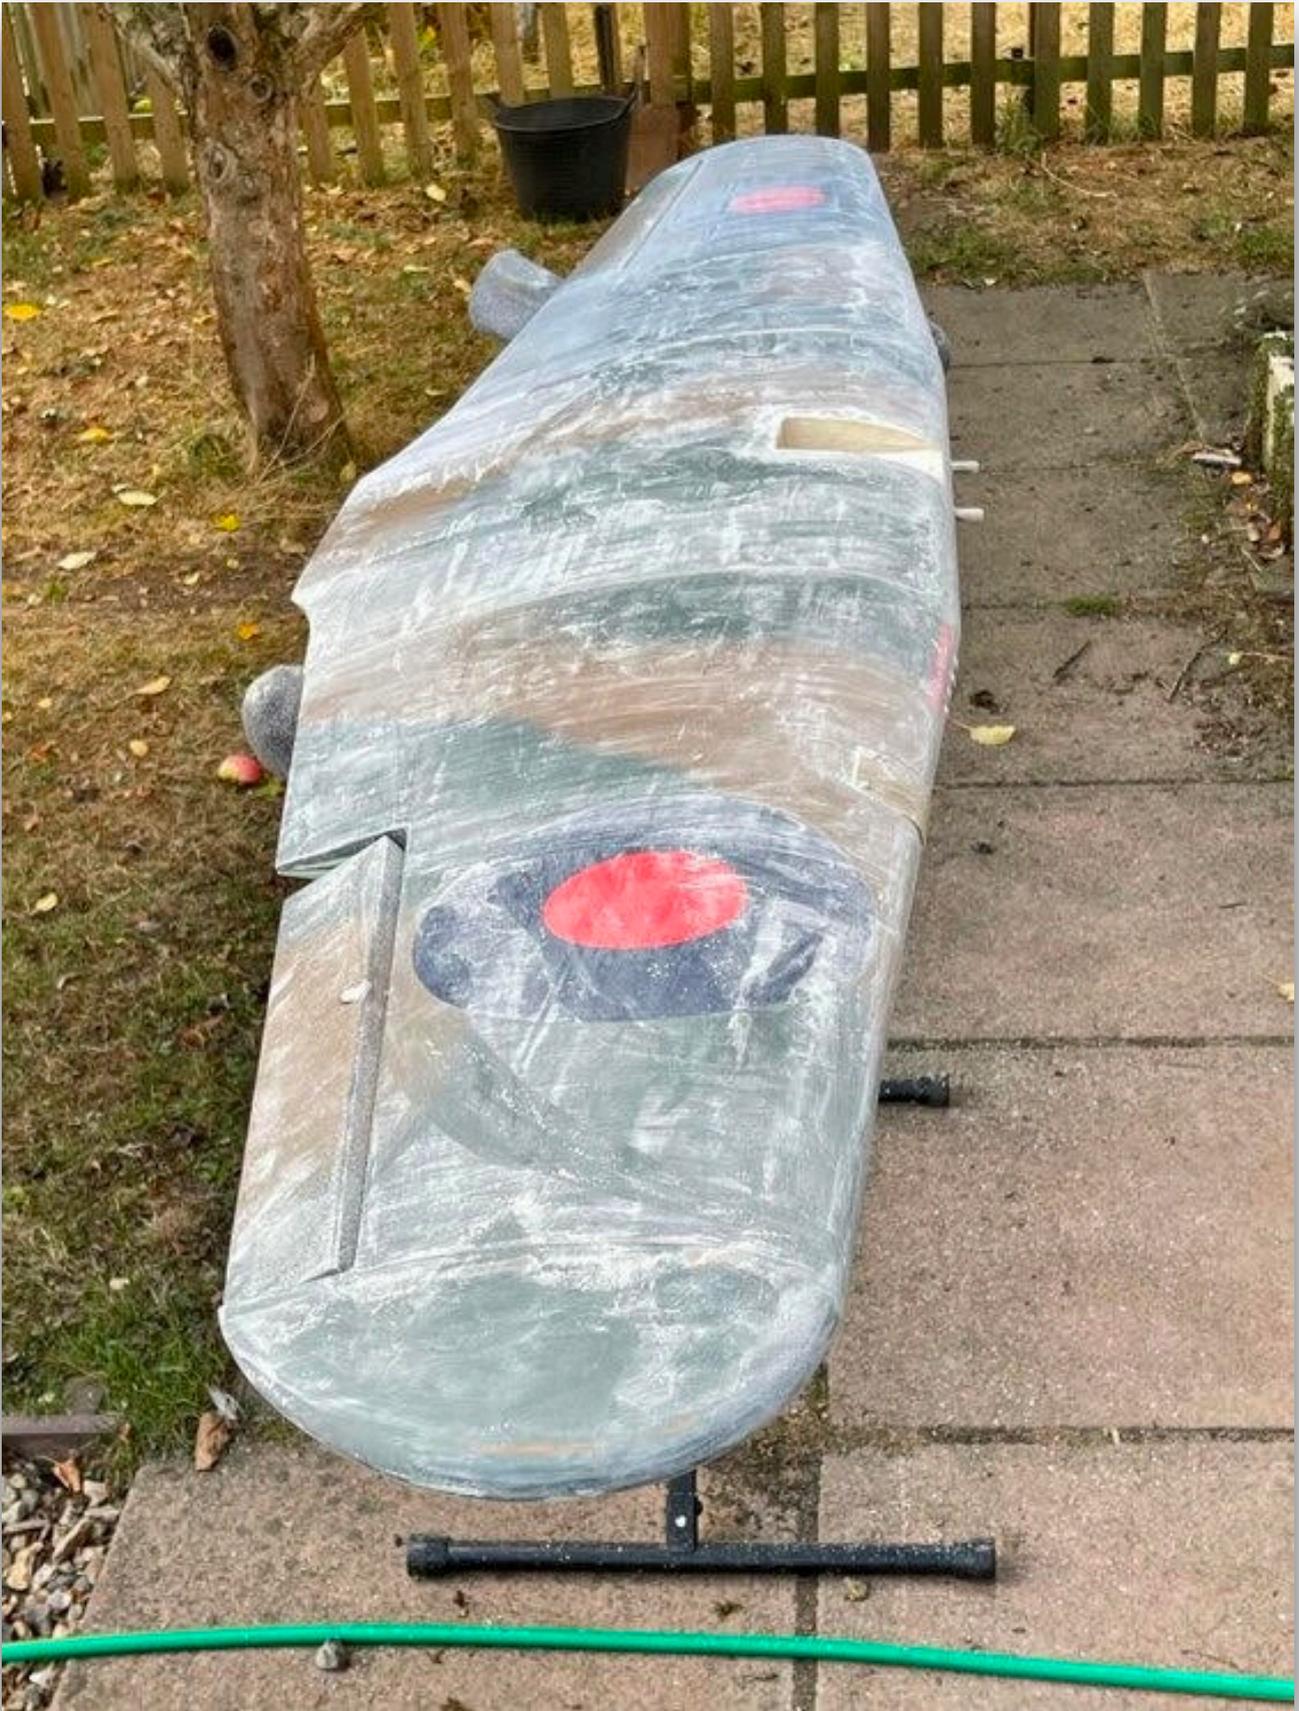
Back to sanding and after 2 hrs I think I've sanded off the fuel proofer that had been applied with a yard brush!

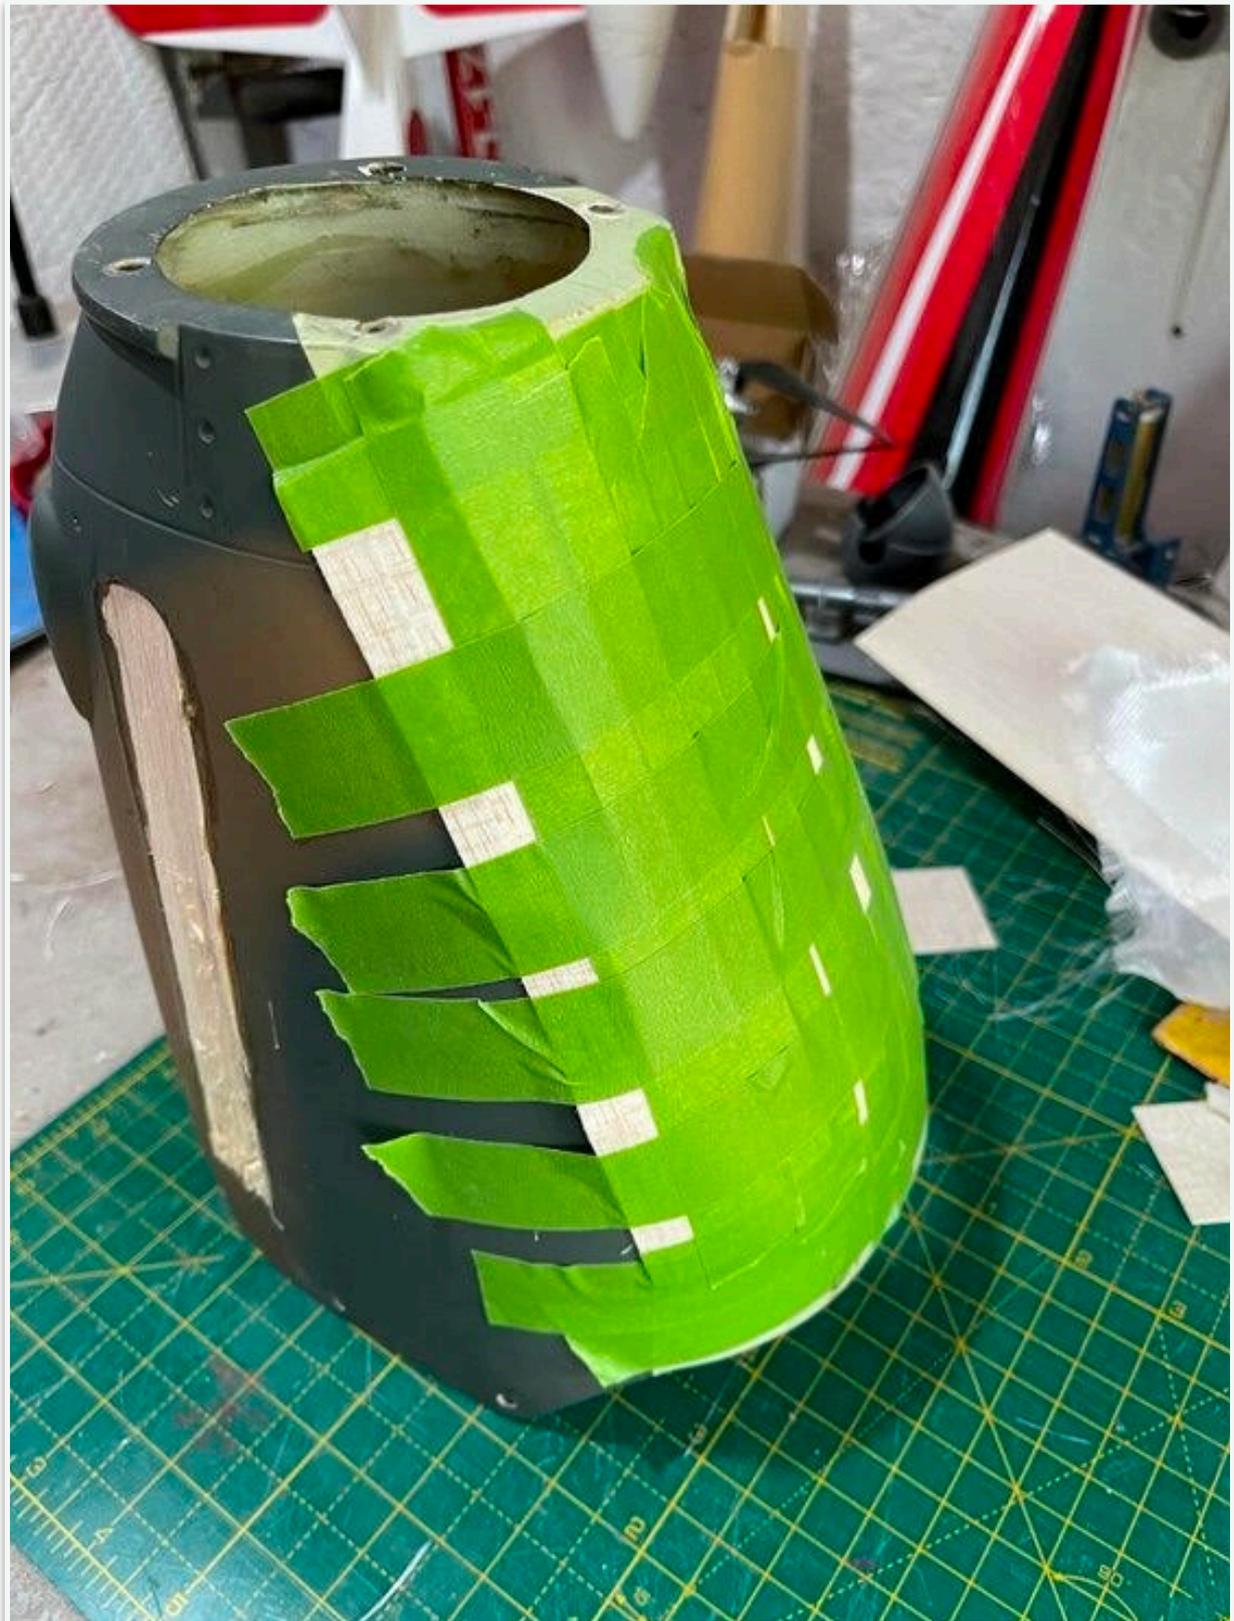
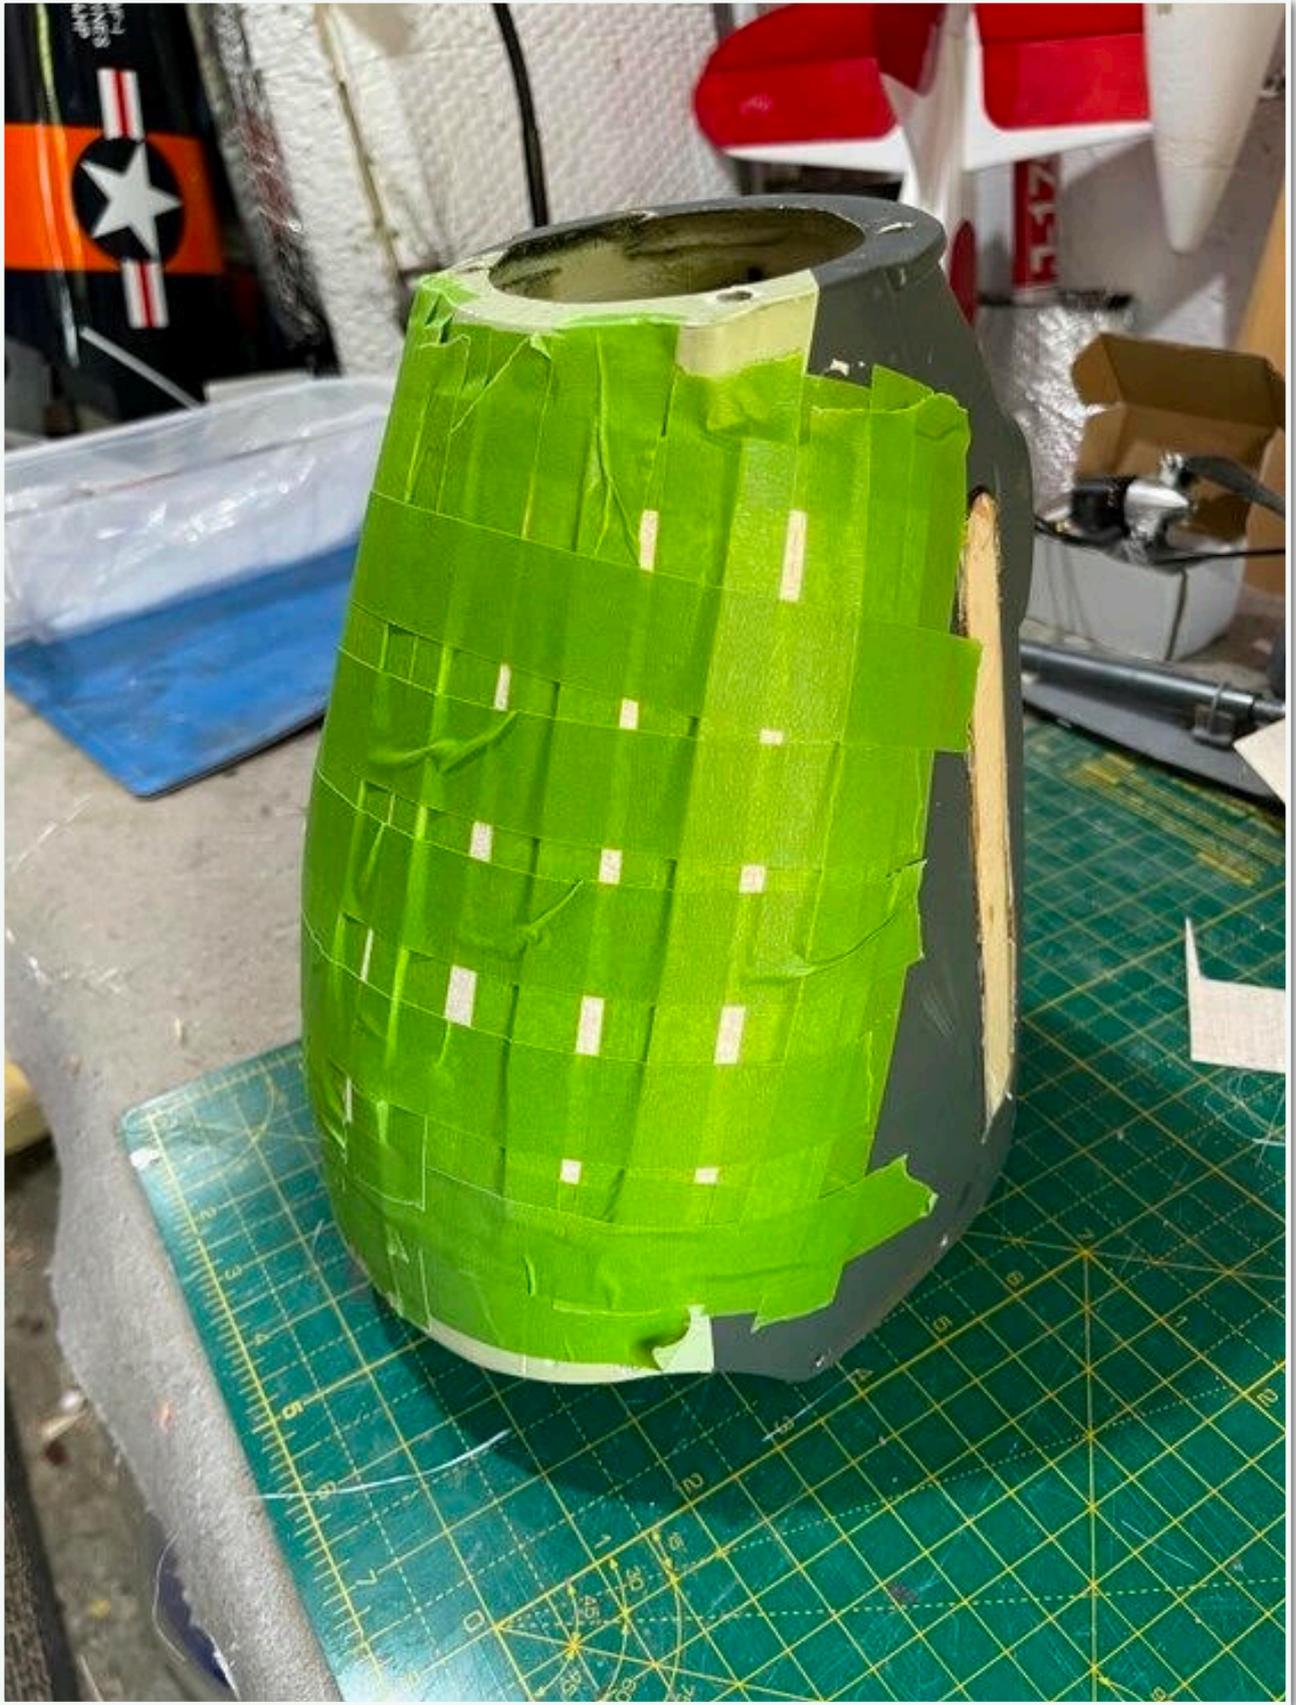
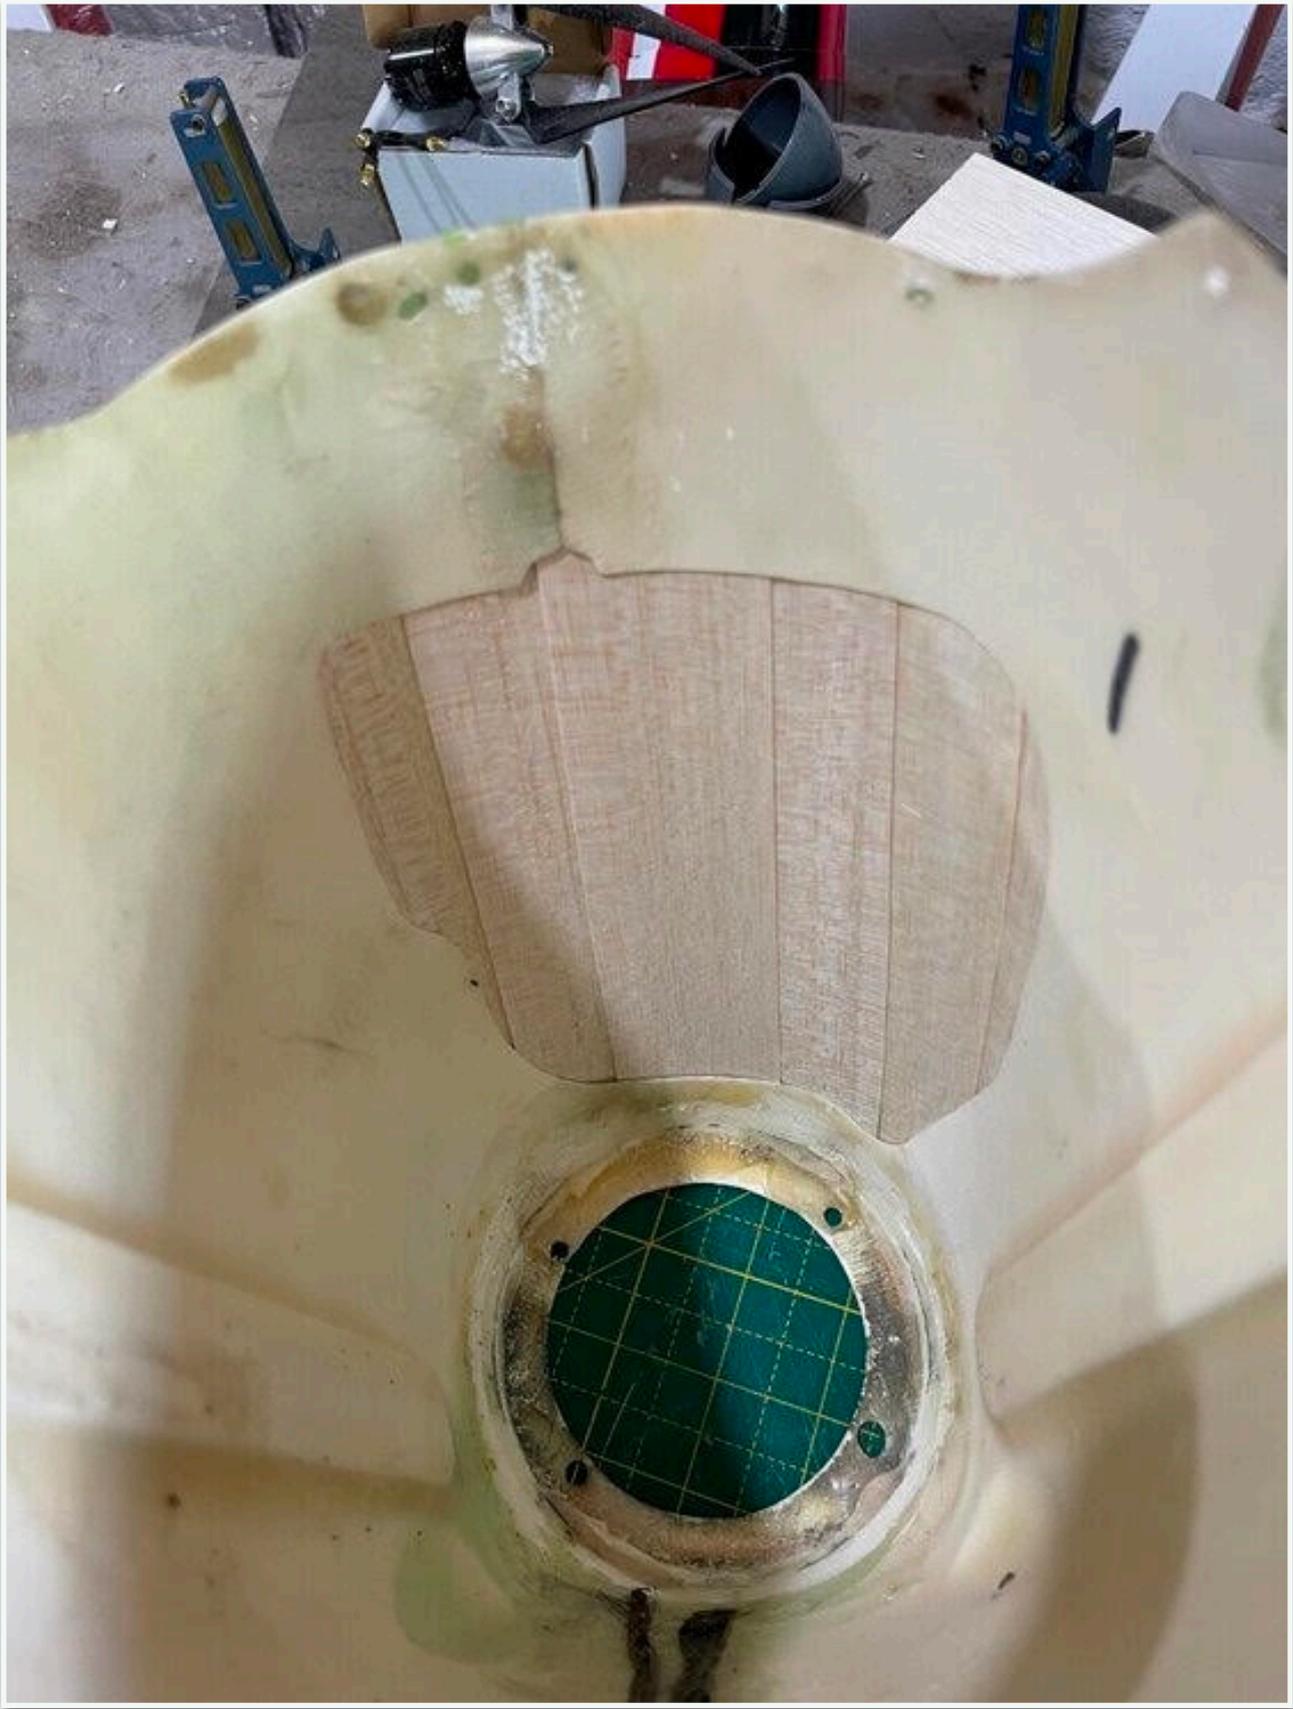
Time to tackle the cow! The previous owner had cut quite a large hole on the underside as he needed clearance for the gas engine he had installed. So this needed filling prior to cutting out for the front pot of the 200i. I got in contact with a US company who had some cowls in stock but thought that I'd do some work on my one whilst waiting for a price for the US one. Good job that I did as the price was a little bit on the high side to put it mildly! Having searched through my workshop I couldn't find any pieces of plastic that could be used as a temporary former to support the glassing so I used strips of old 1/32 sheet balsa instead.

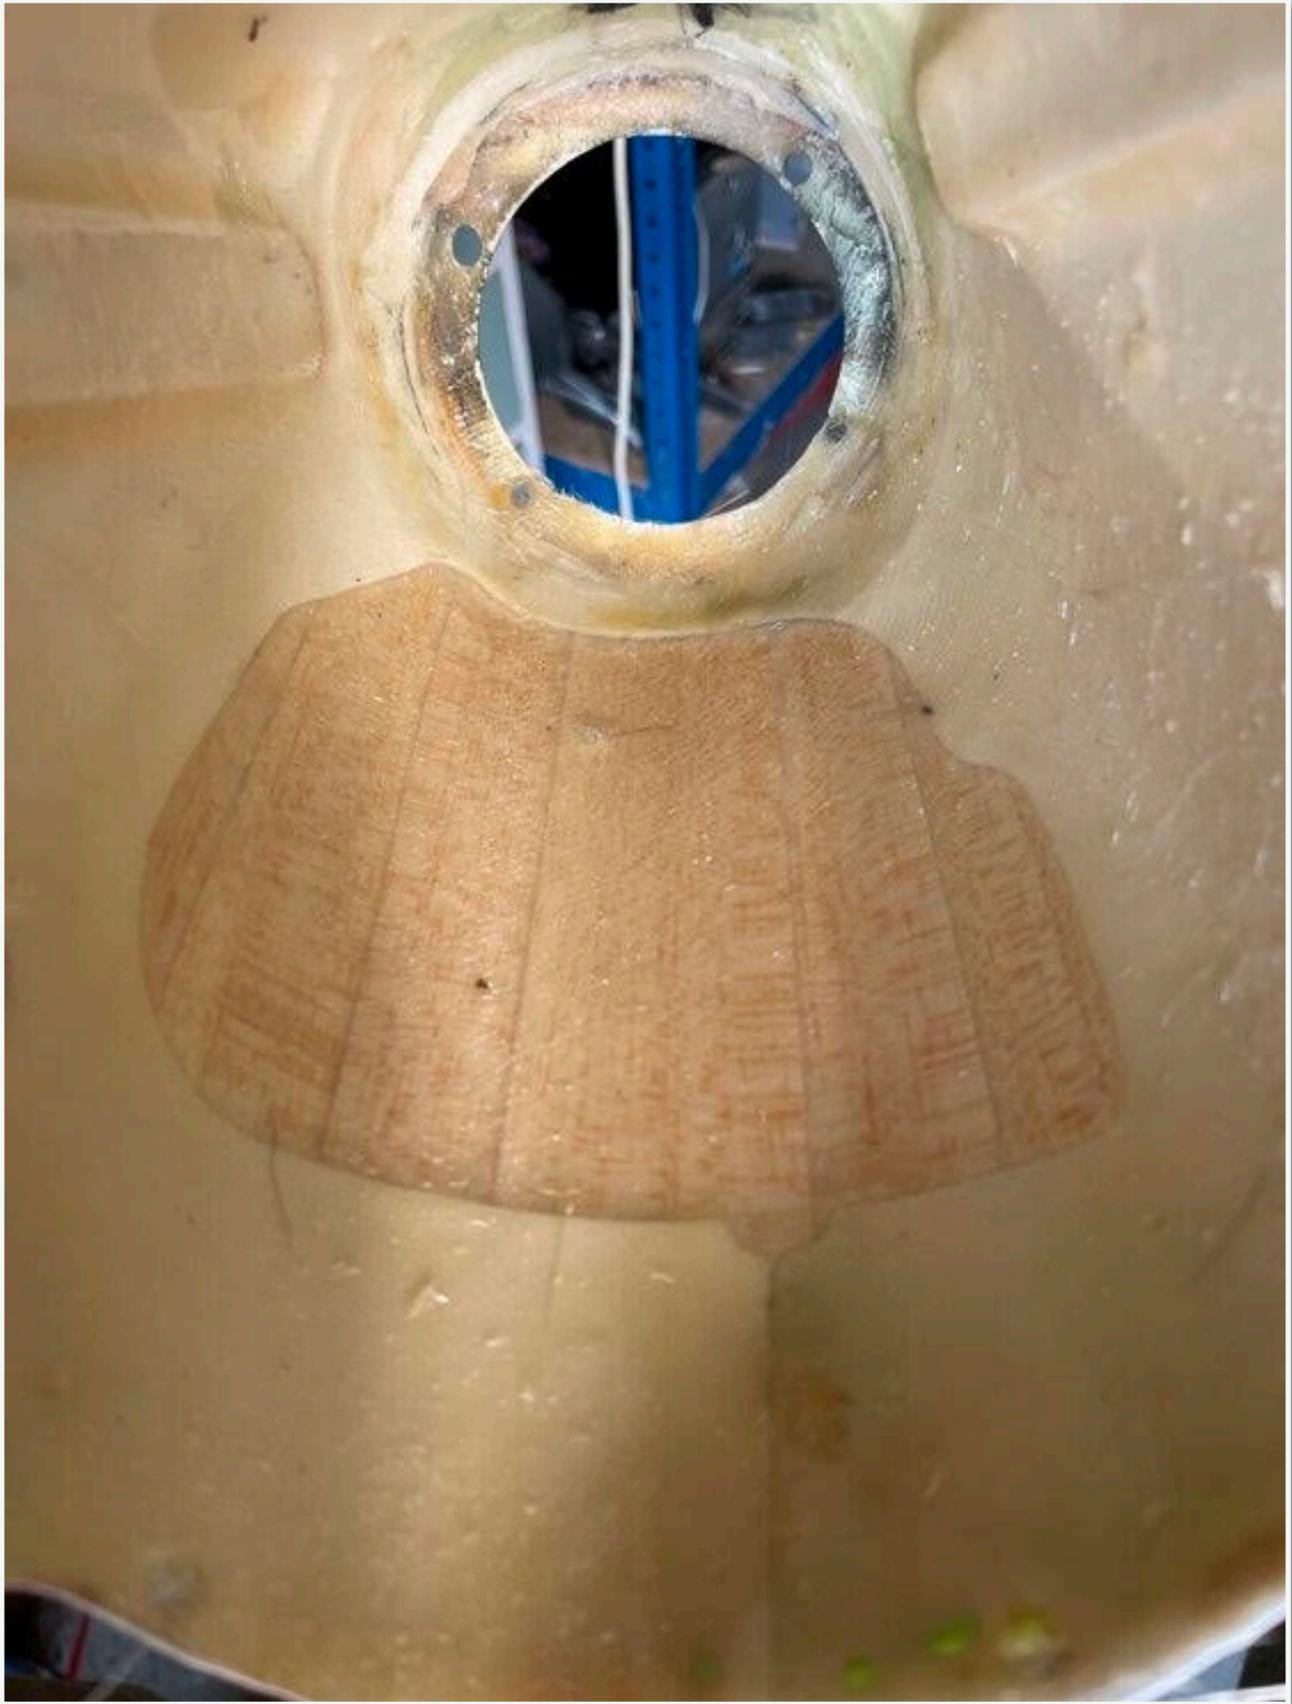
The inside was then glassed.

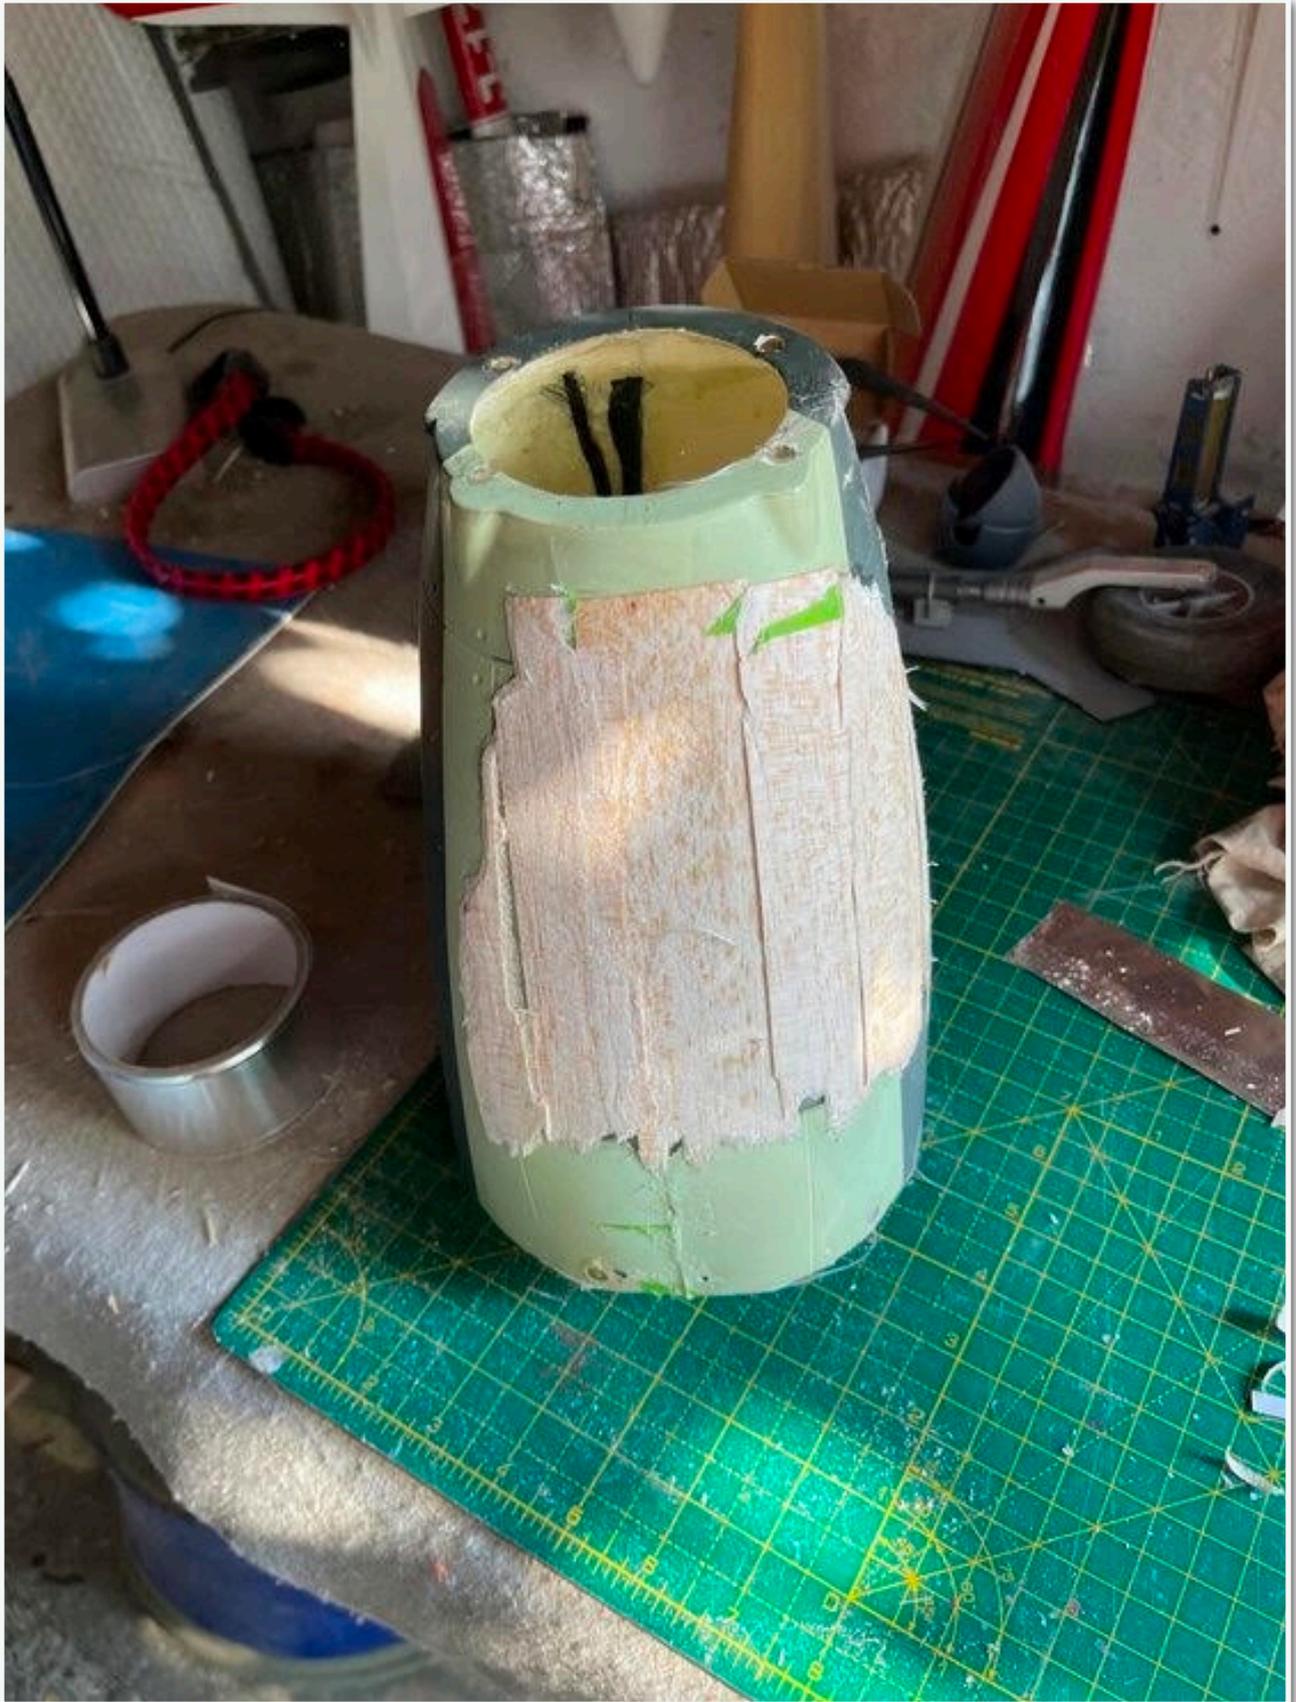
Leaving this on the outside which will be sanded down.

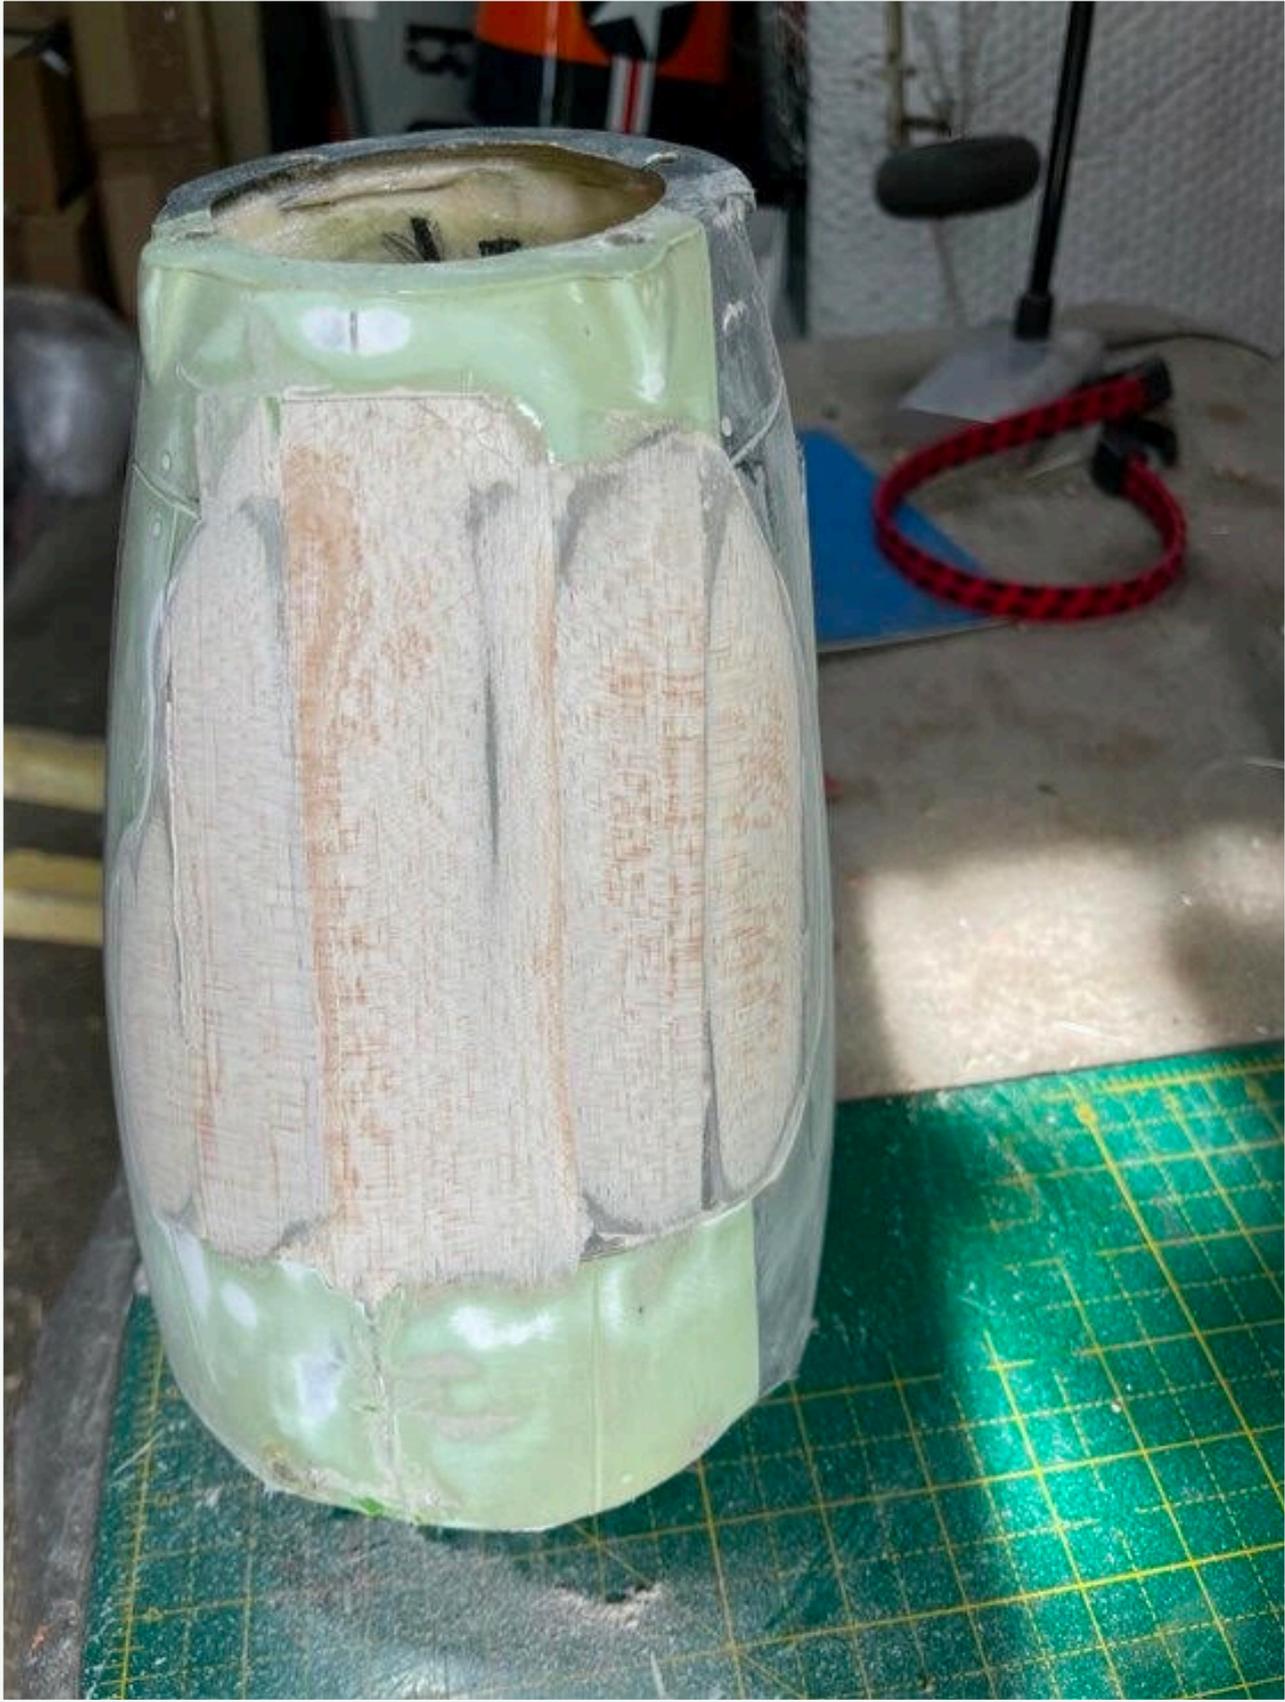
And 10 minutes later sanded ready for a bit of filling.
