Peter Jenkins - B J Craft Anthem with TMCR, Part 8

Oops

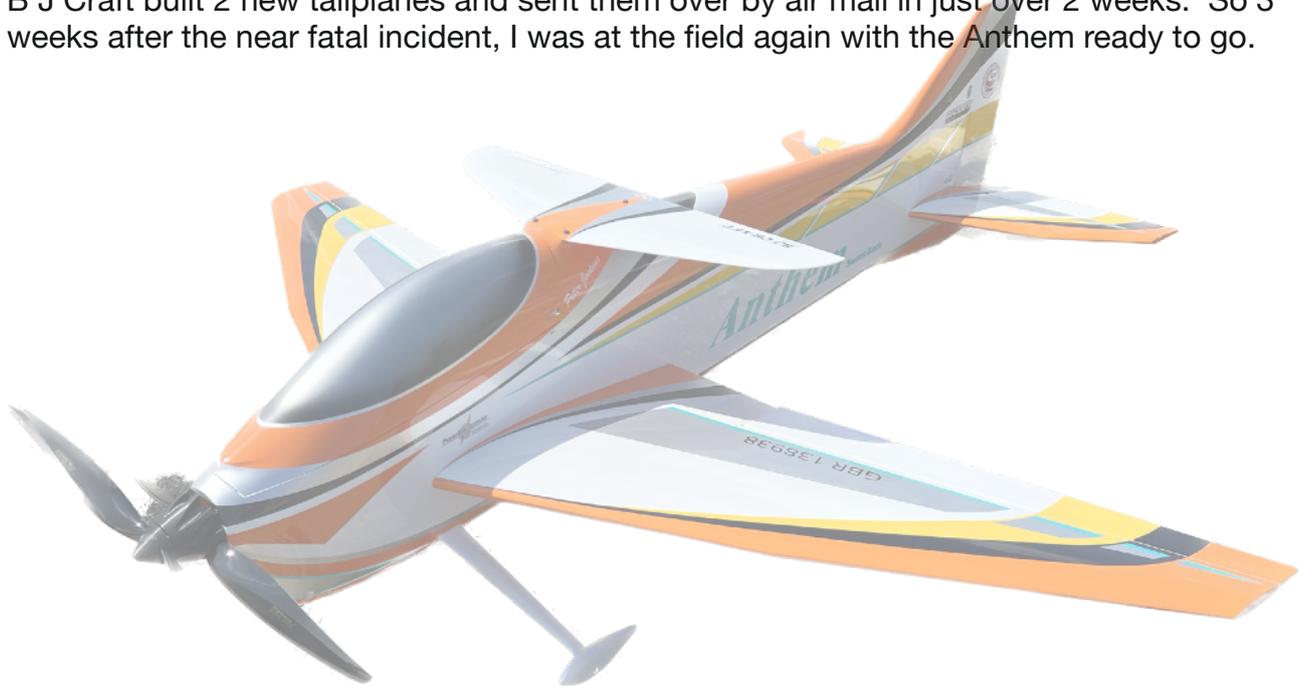
B J Craft built 2 new tailplanes and sent them over by air mail in just over 2 weeks. So 3 weeks after the near fatal incident, I was at the field again with the Anthem ready to go.
