# SIG Rascal 110" renovation, 9

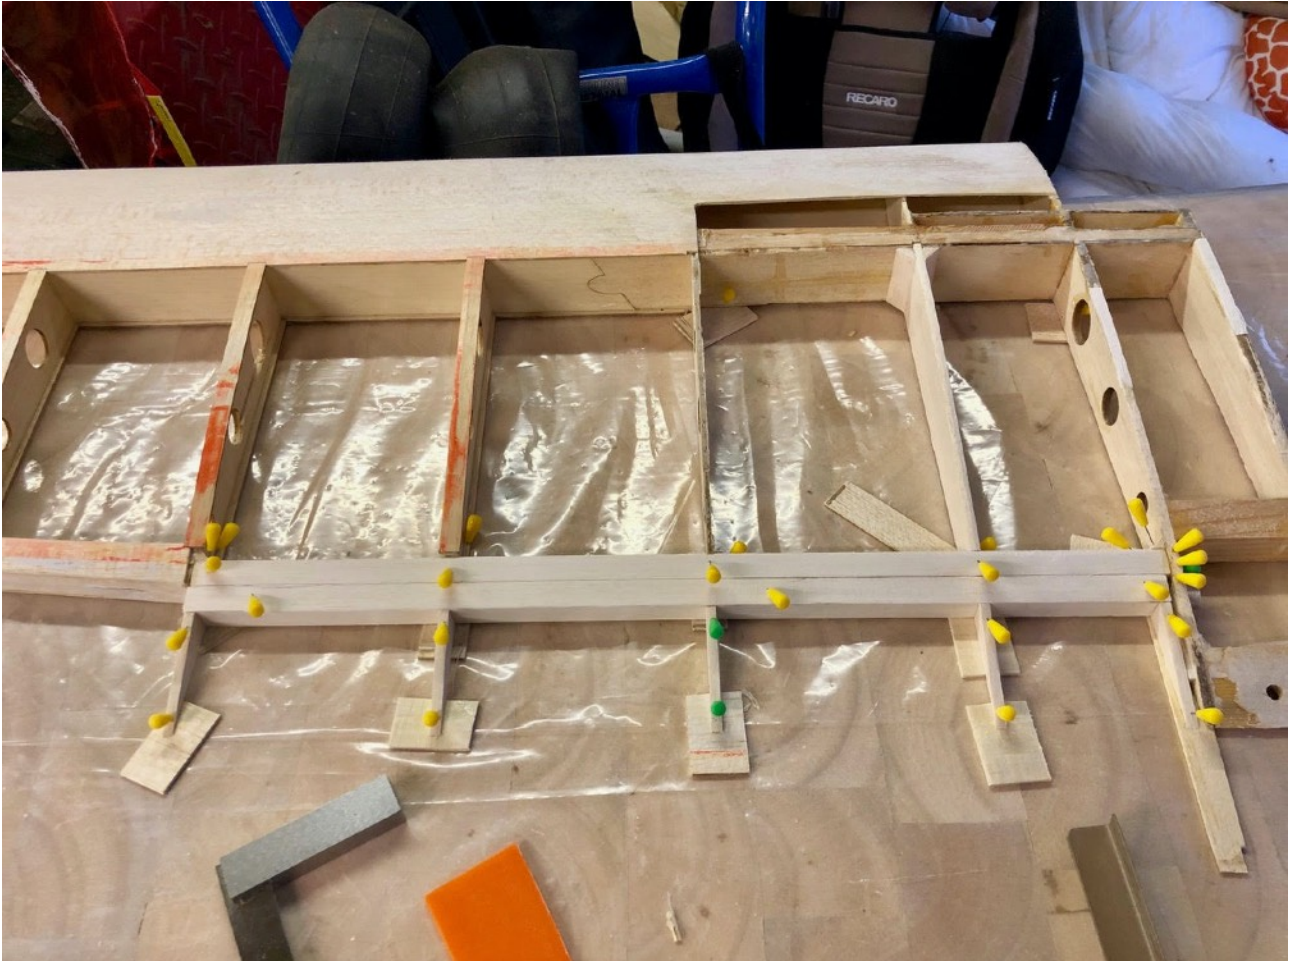
Following on from fitting the false TE on the wing I then cut out the riblets and LE for the flap and fitted them.

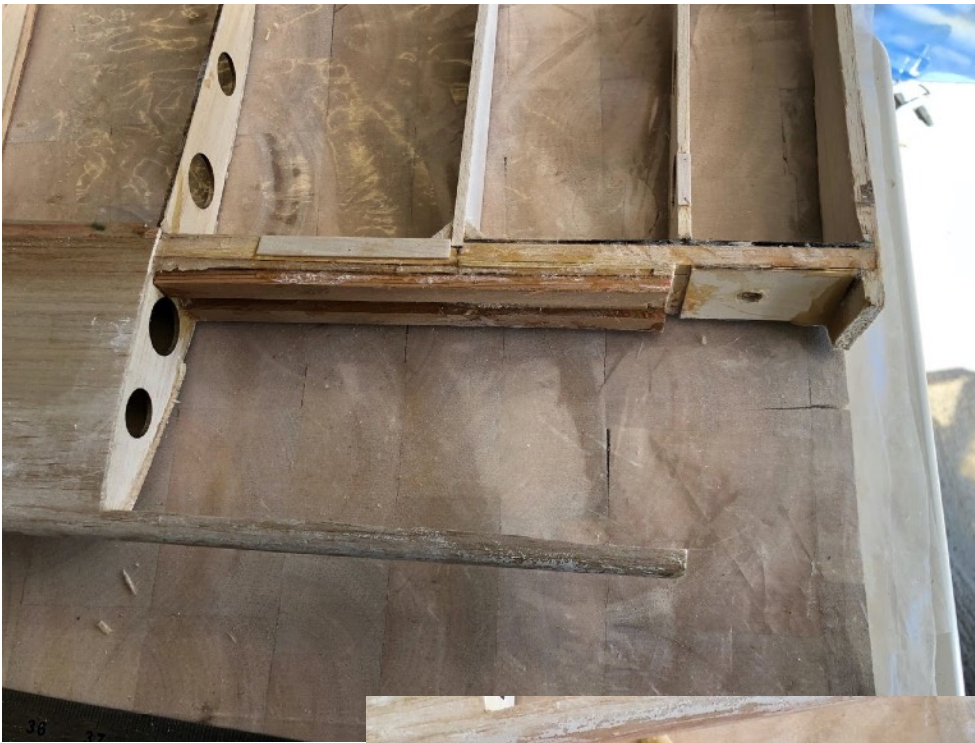
When I went to the workshop today I couldn't help but get annoyed with the state of the wing around the spar and D box just outboard of the root. I made up my mind that the only way to cure this was to be drastic so out with the razor saw and soon I was left with this.

At this stage it seemed like I was cutting off more than I was adding! The remaining old repairs don't look nice but to be fair they are strong so I will leave them as they are, some more packing up to get the right levels may be required but we'll see.

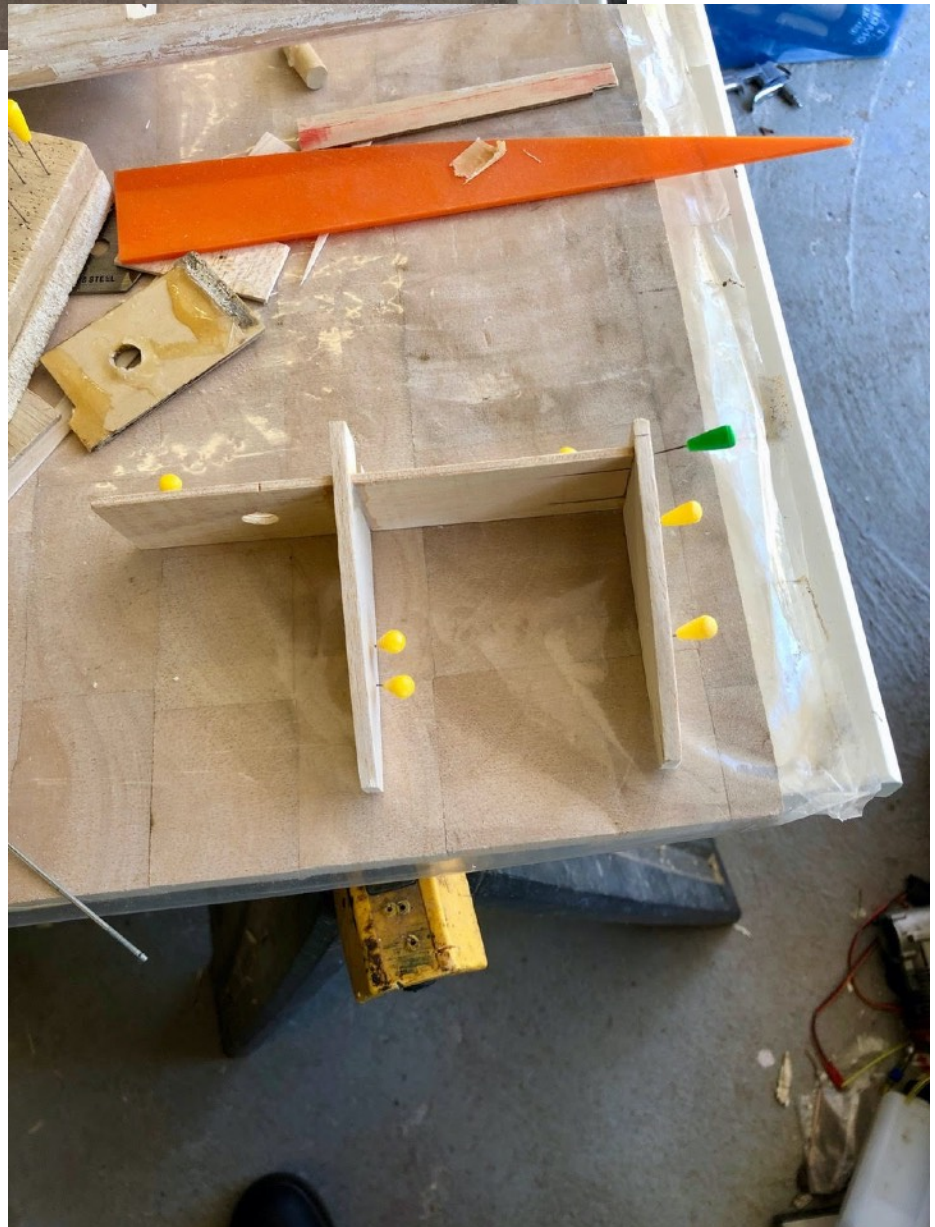
Next up was a new D box section to replace the bits I'd just removed, this was formed from ply with new hard balsa ribs.

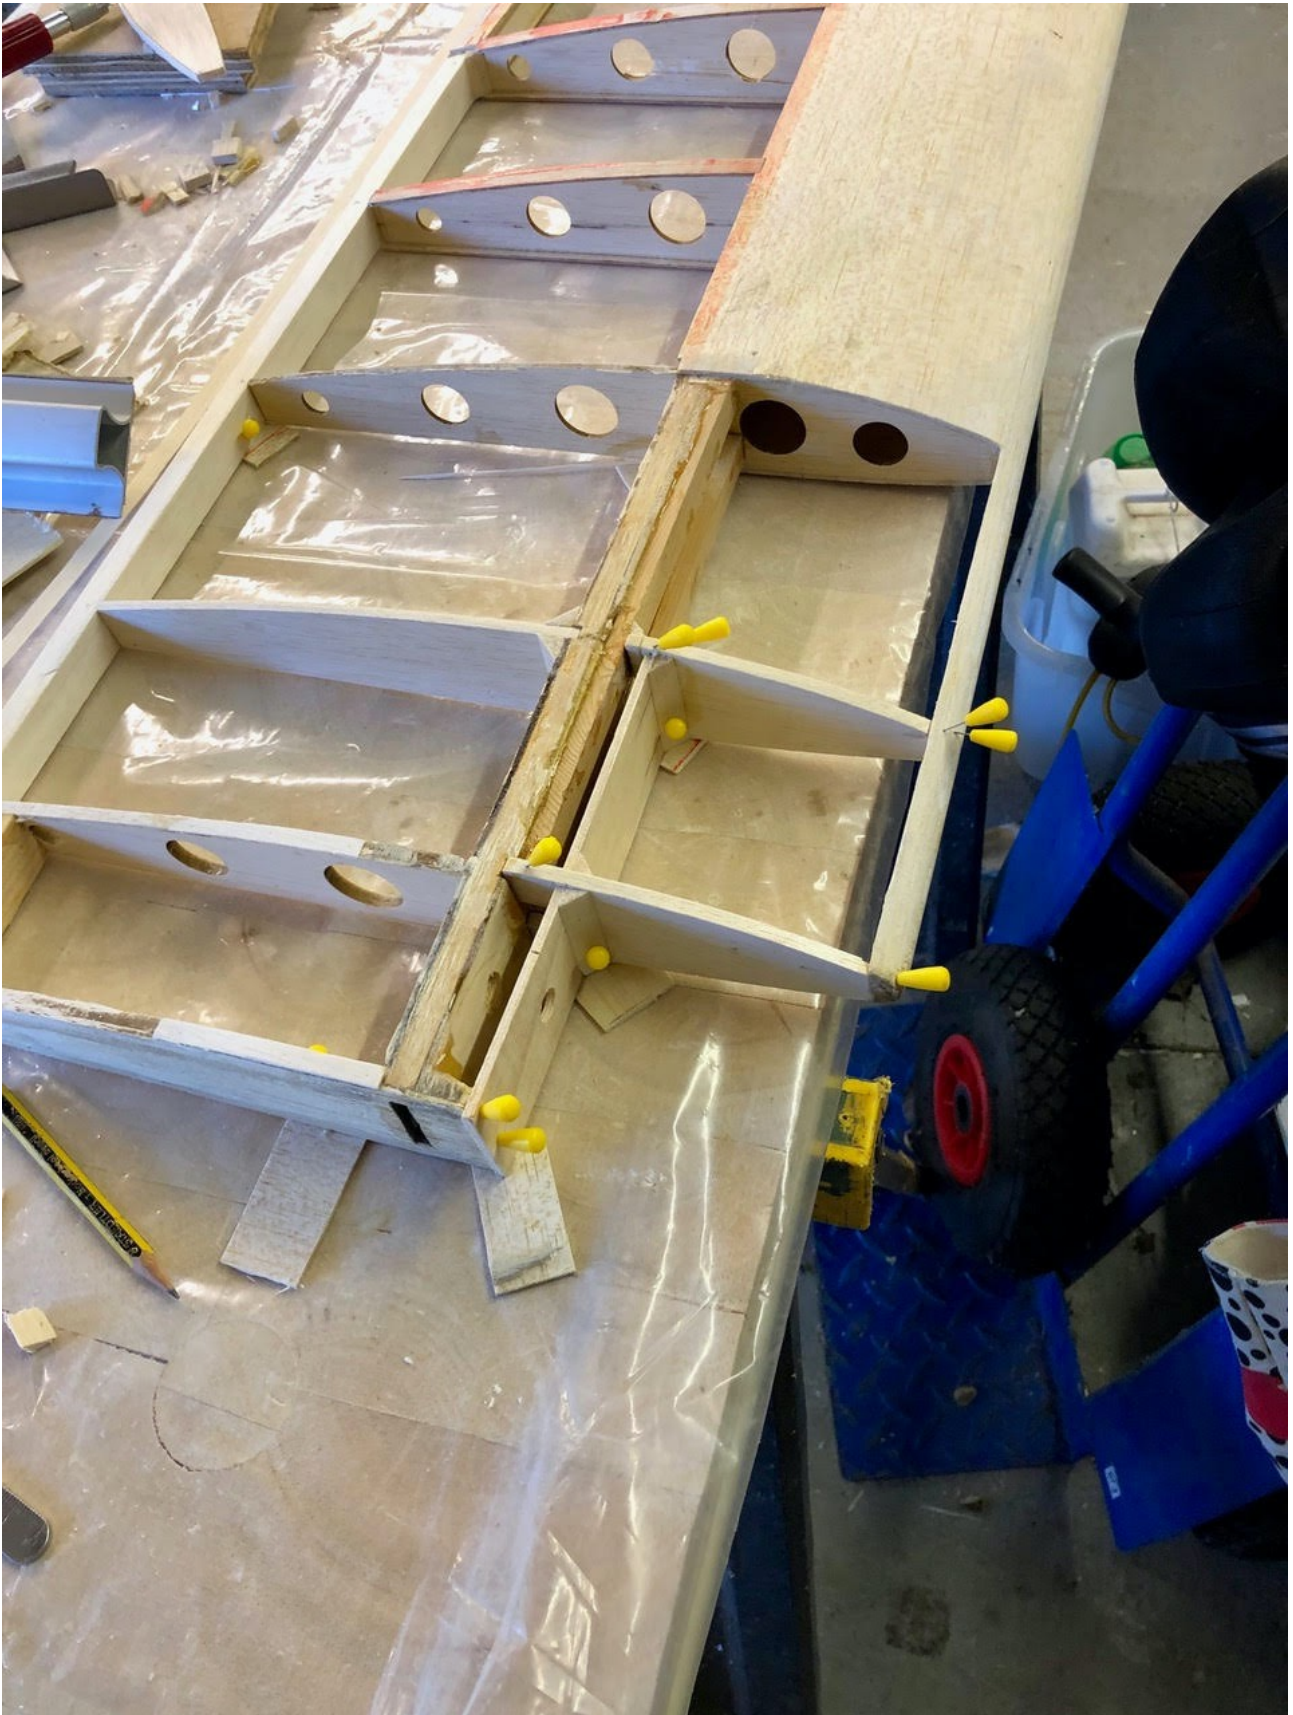
Once dry I fitted to the wing and am happy that it now looks a lot better, is stronger and things now line up!

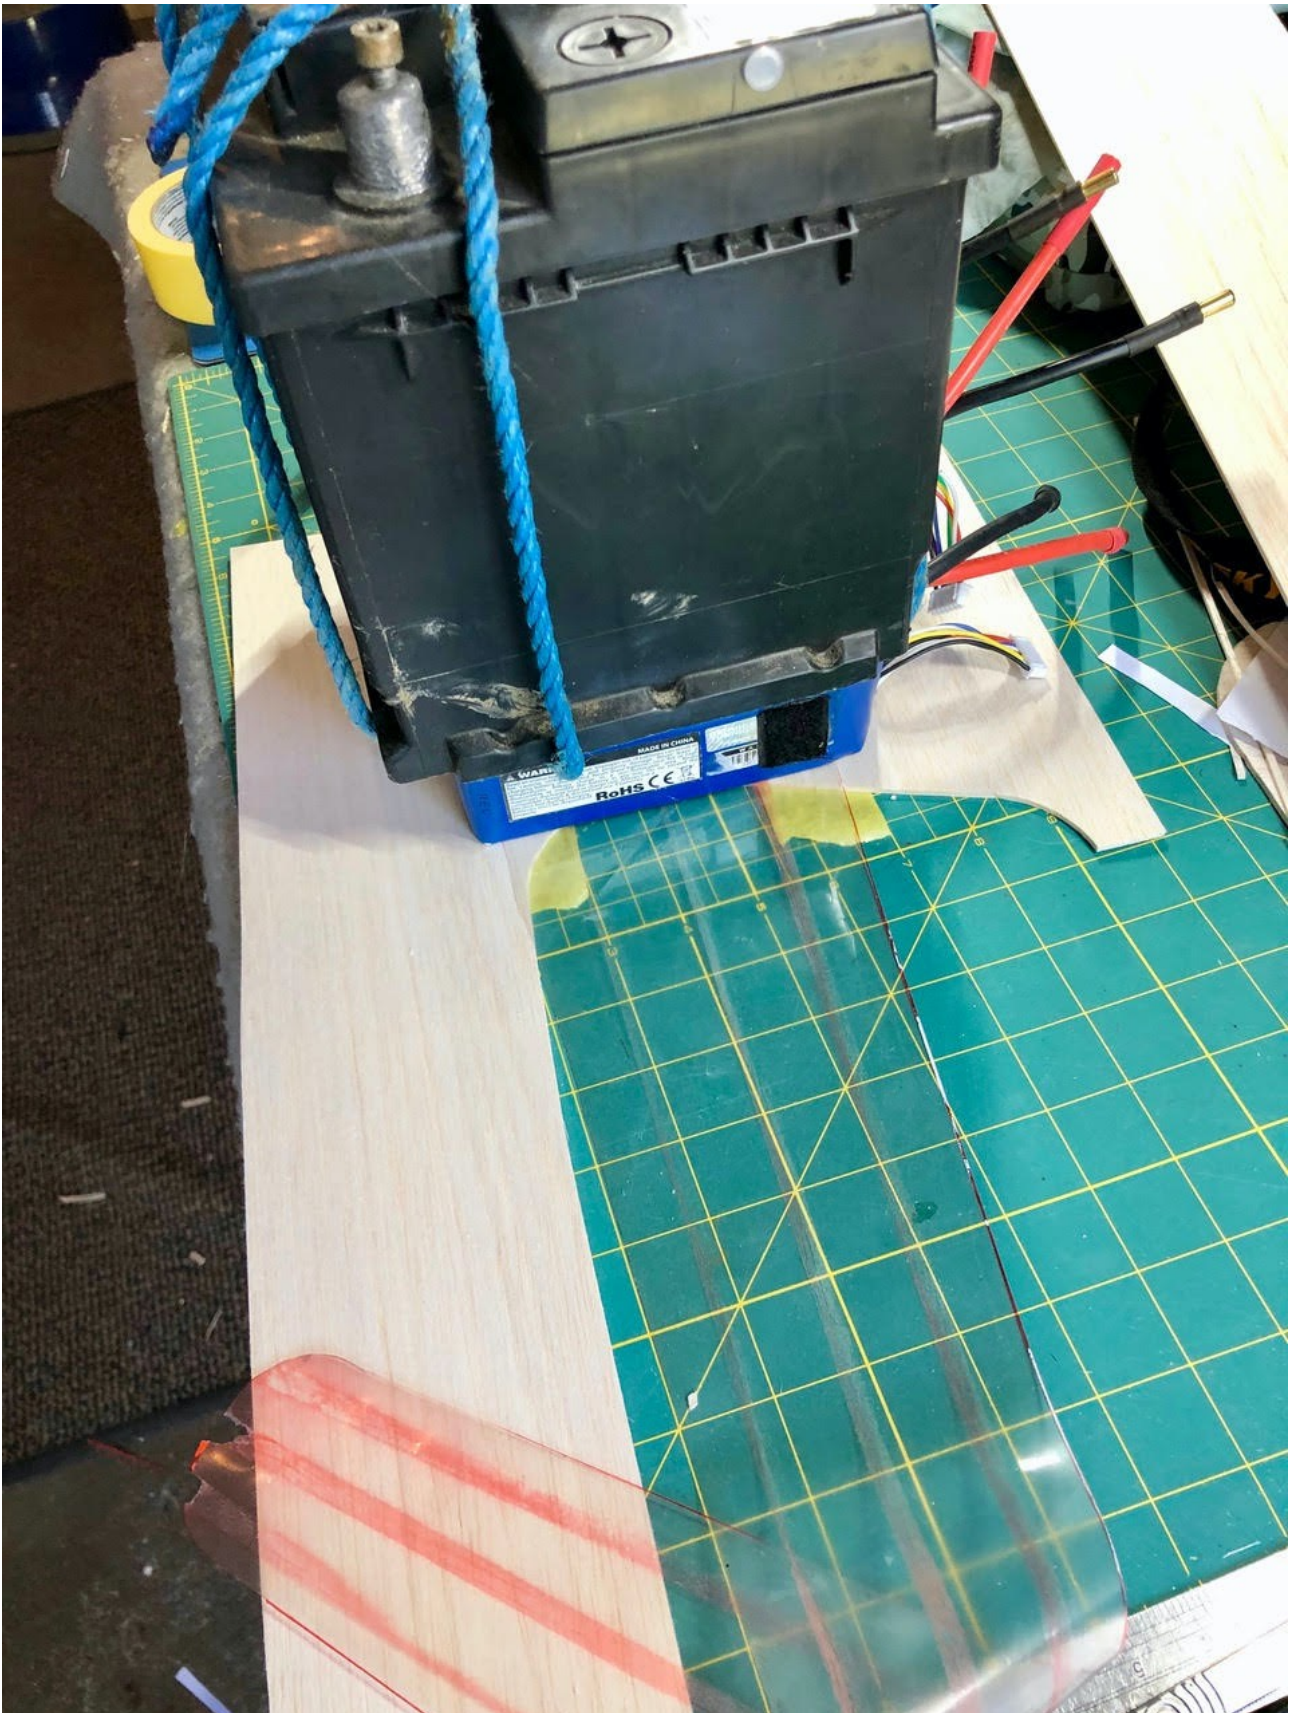
I've now left that to dry overnight so I decided to cut out some of wing sheeting and used the good wing as the template for the shaped cutouts (didn't take a shot of this!). Once cut, the sheets were taped together, bent back and glue applied.

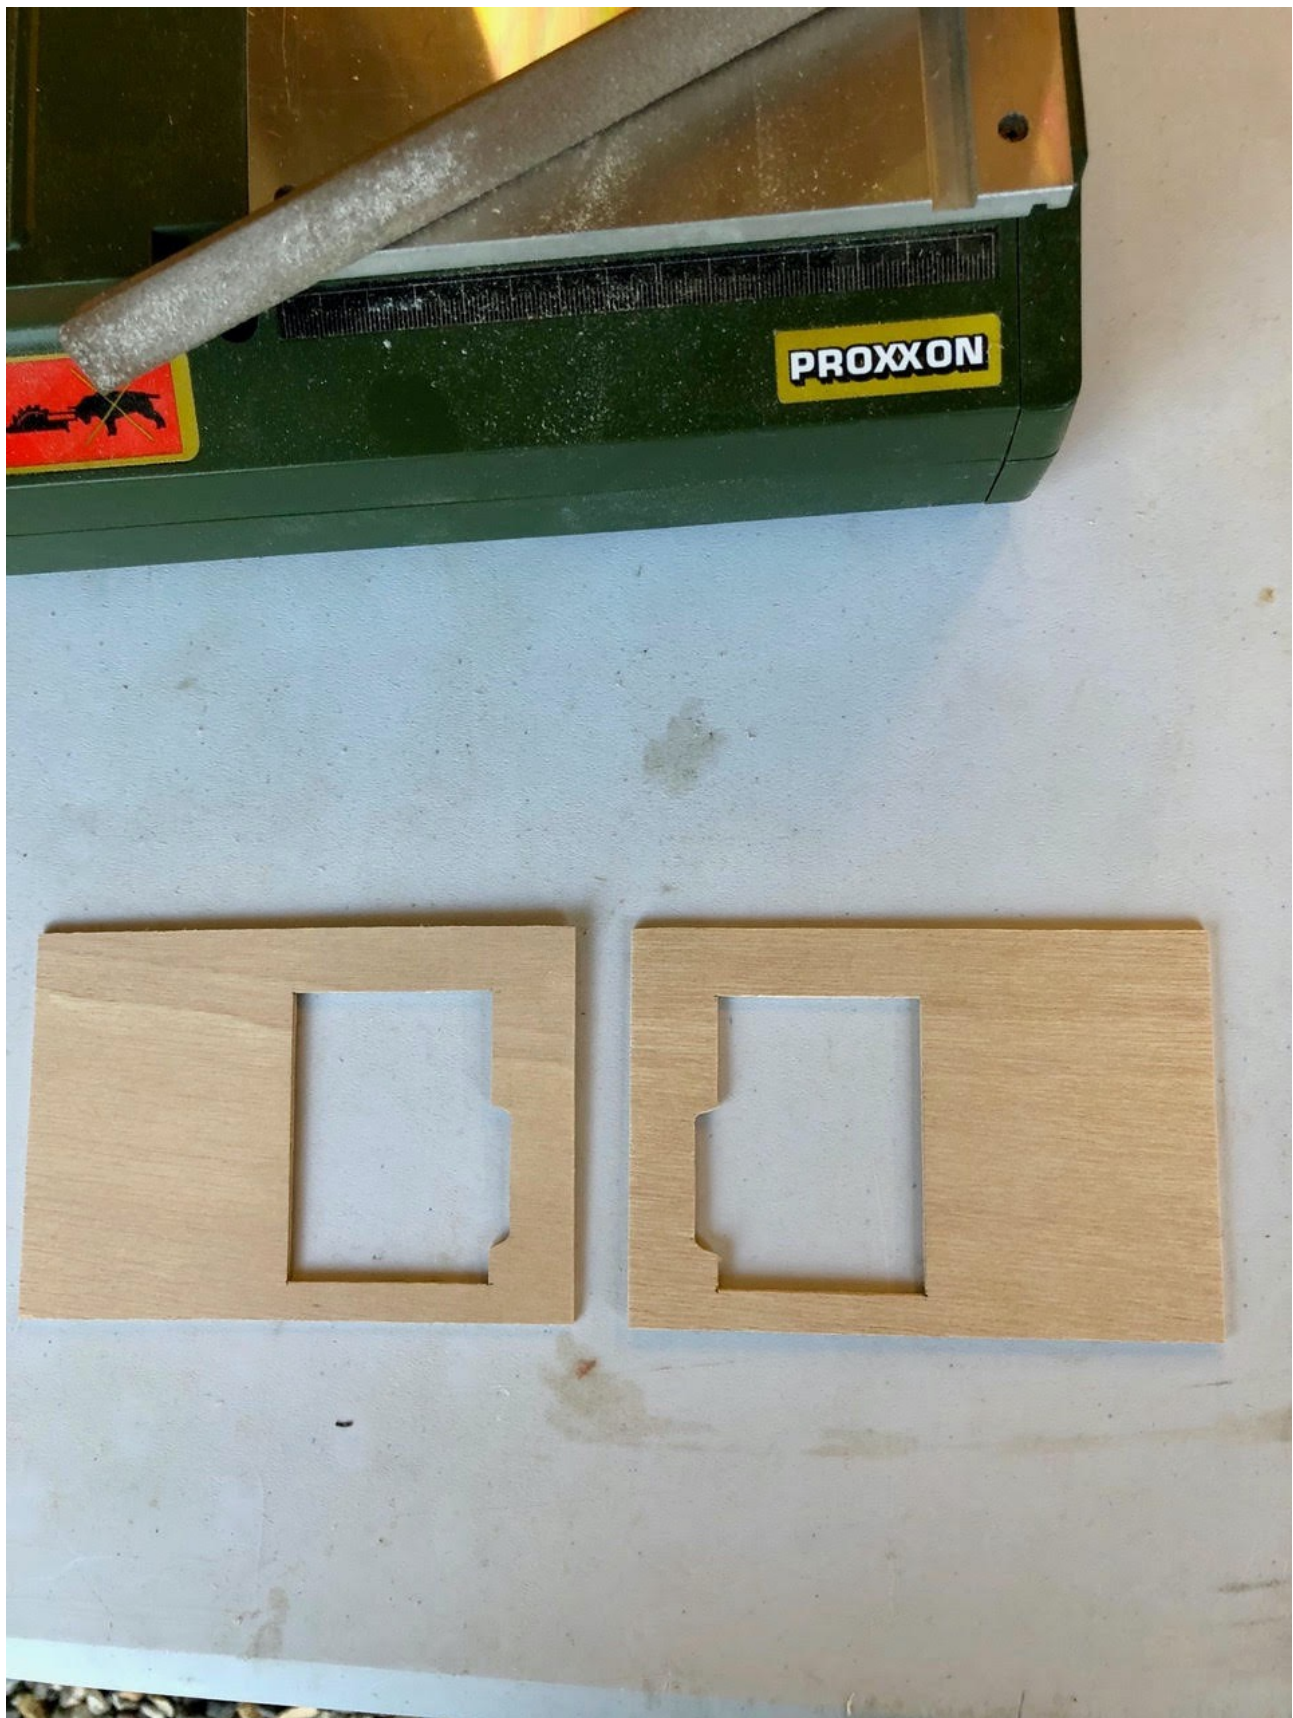
These have also been left to dry overnight but I had one last job I wanted to get done today and that was to cut out the new flap servo mounting plates using the good wing as the template.
