SIG Rascal 110" renovation, 11

The repairs and improvements to the wings continue.

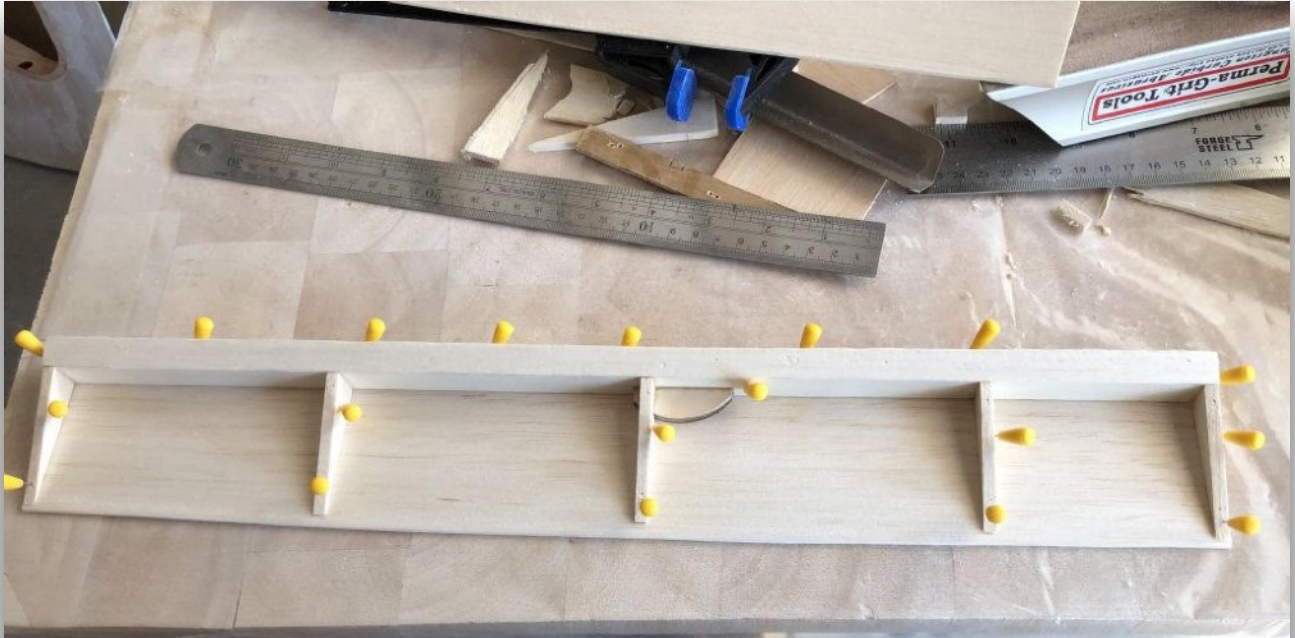
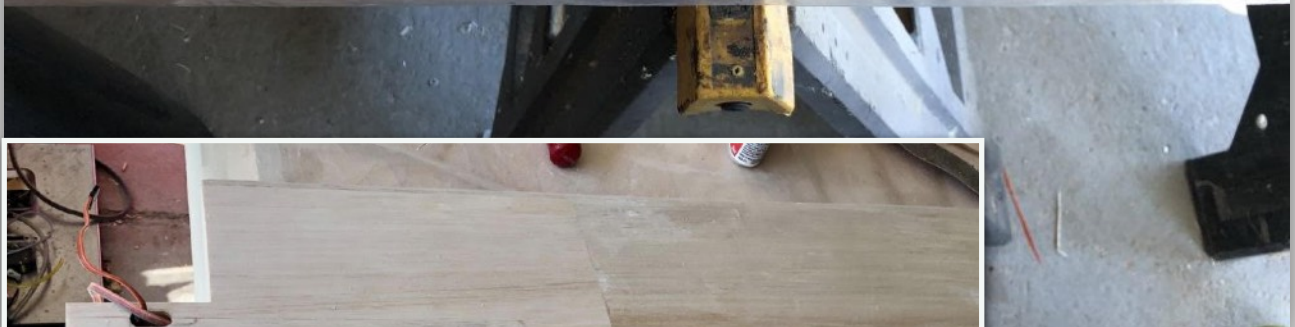
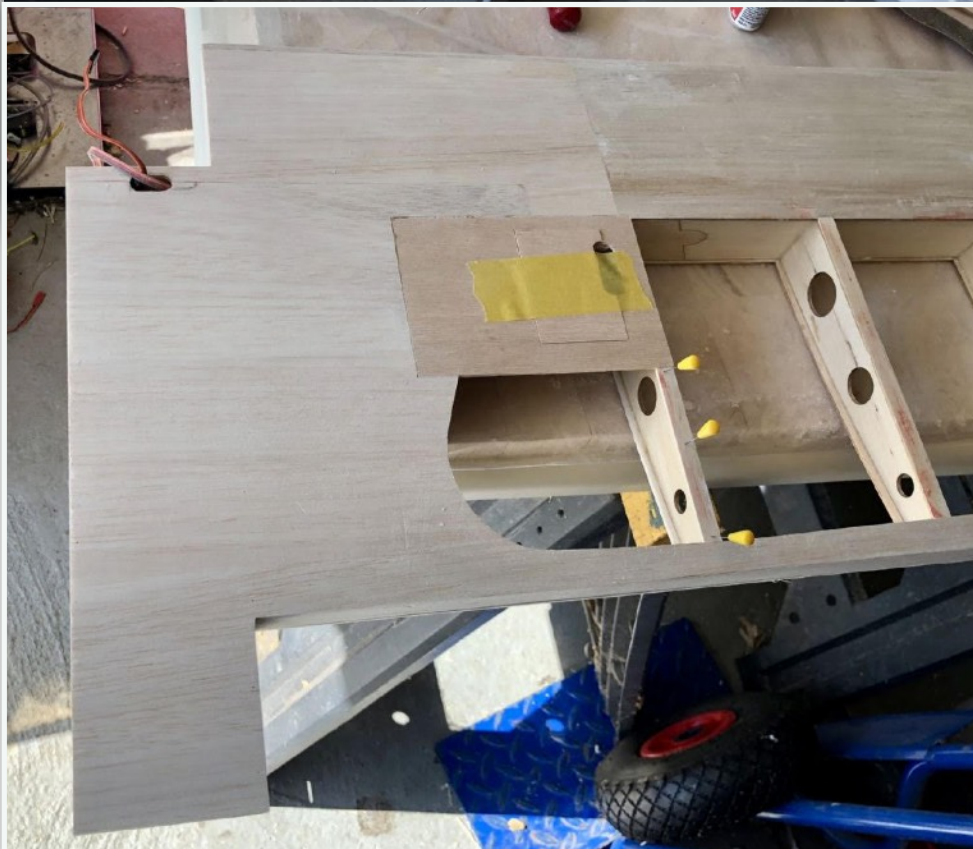
New flap being made with ply hard point for control horn mounting.

New flap servo mounting plate fixed and underside balsa sheeting added and I remembered to fit the servo cables in place before the sheeting went on, much easier than leaving a draw string in.

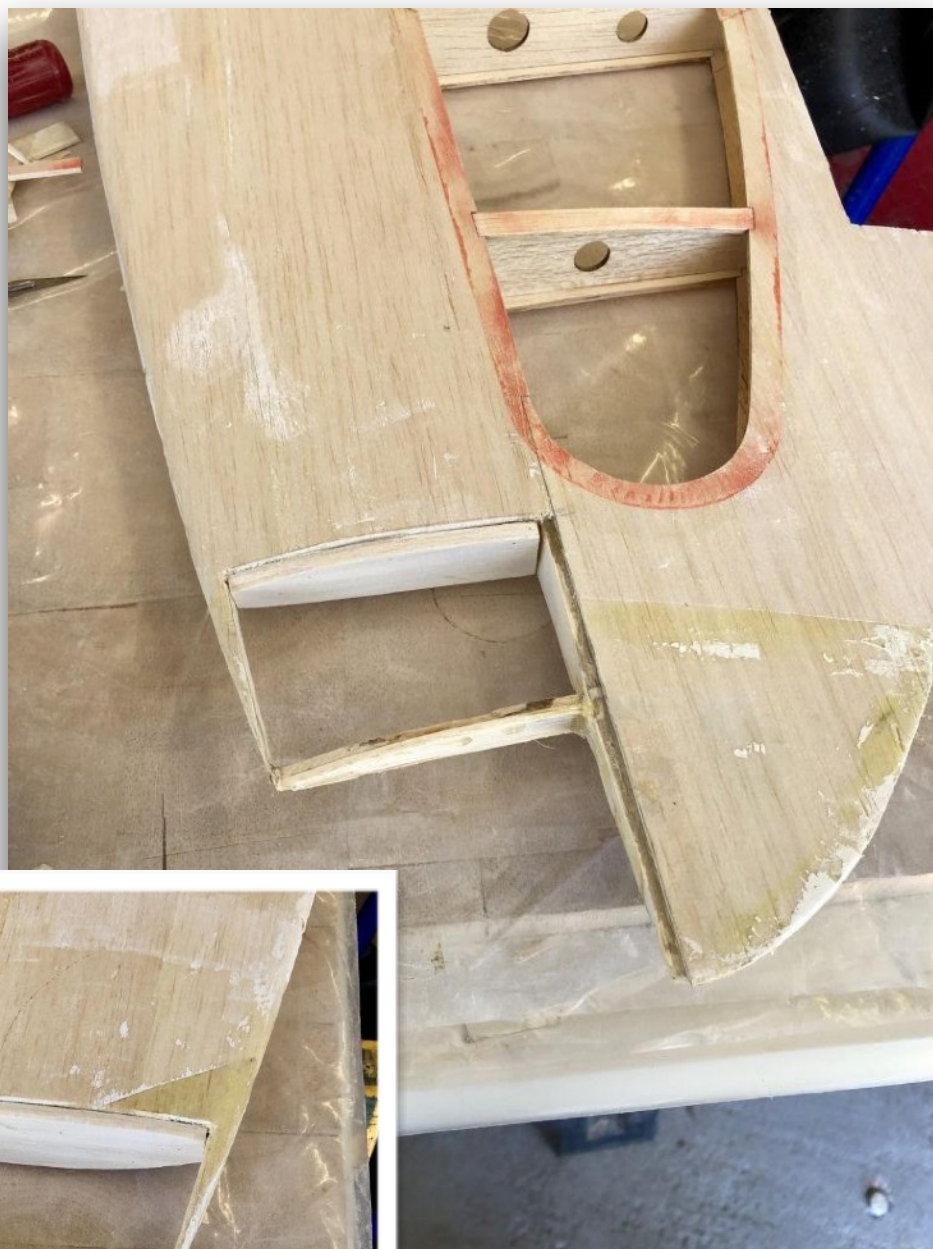
Underside

Now on to the wing tip. I cut back some more of the old balsa that showed signs of previous repairs and fitted a rib doubler so that the new sheeting would have something to stick to.

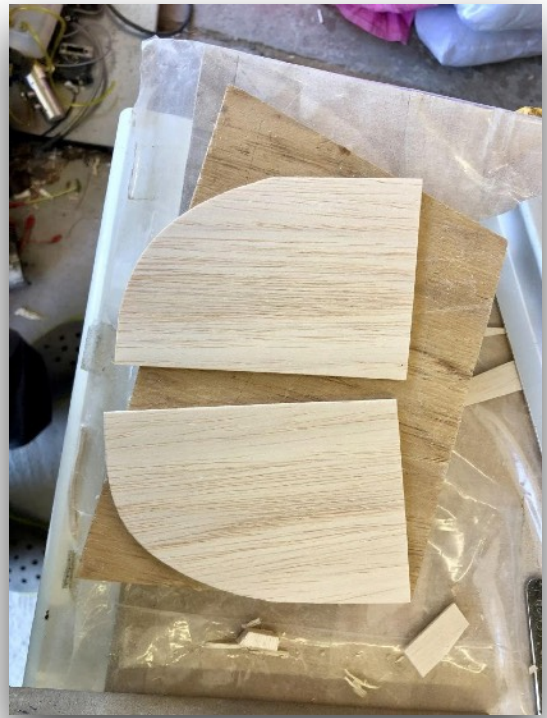
Tip sheeting cut out and ready to fit.

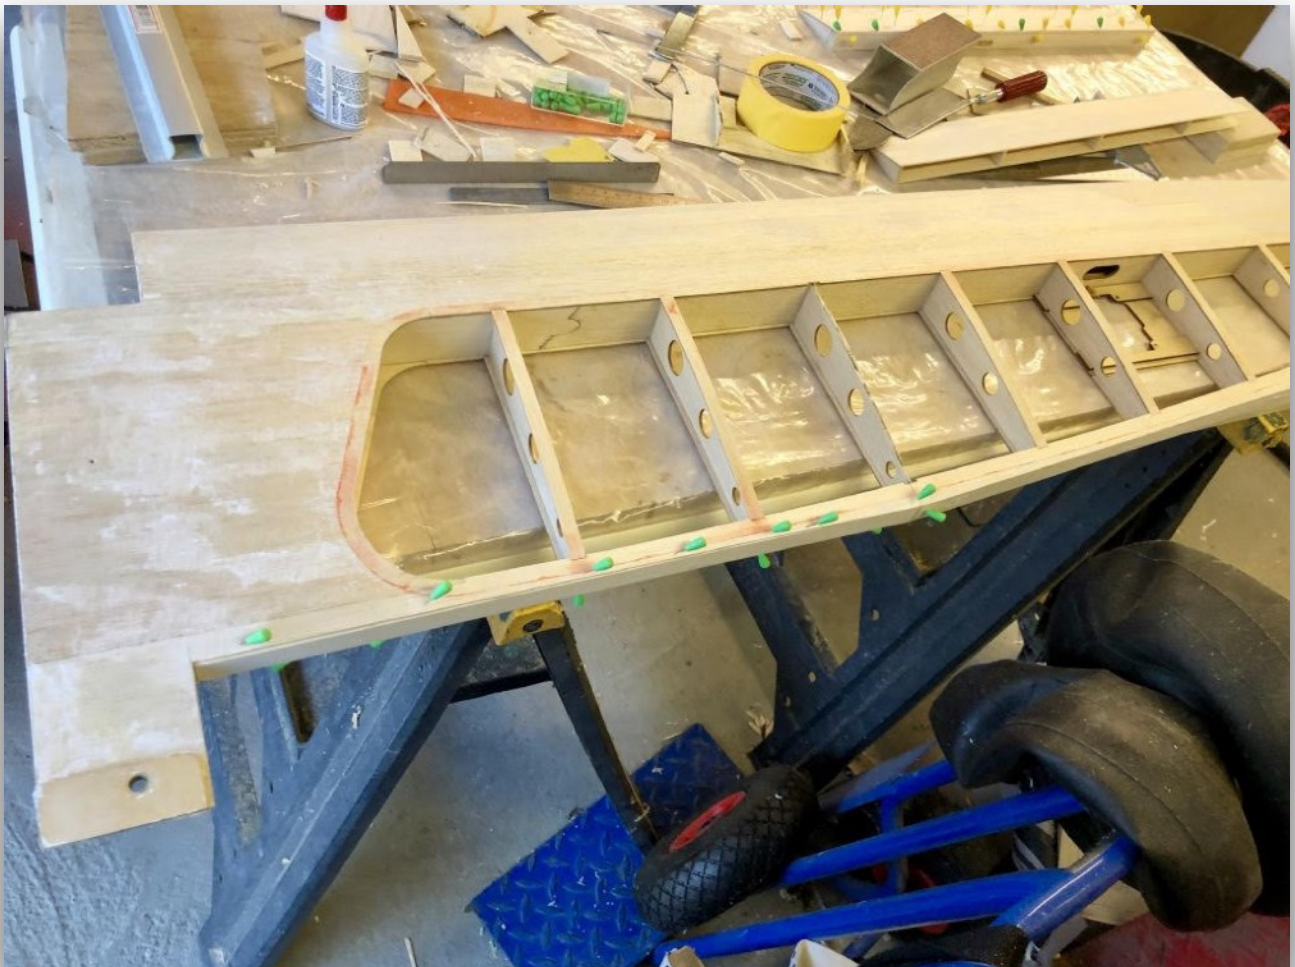
This next picture shows the wing with the false TE being stuck. Each rib had to be cut back, within the existing sheet covering to allow for the TE to fit, another fiddly job.

Then it was out with the razor saw and knife and the other wing was attacked to cut out the wing section ready for the new flap. I took a lot of time over this as I wanted to make sure that the piece I cut out was good enough to be used as the flap.

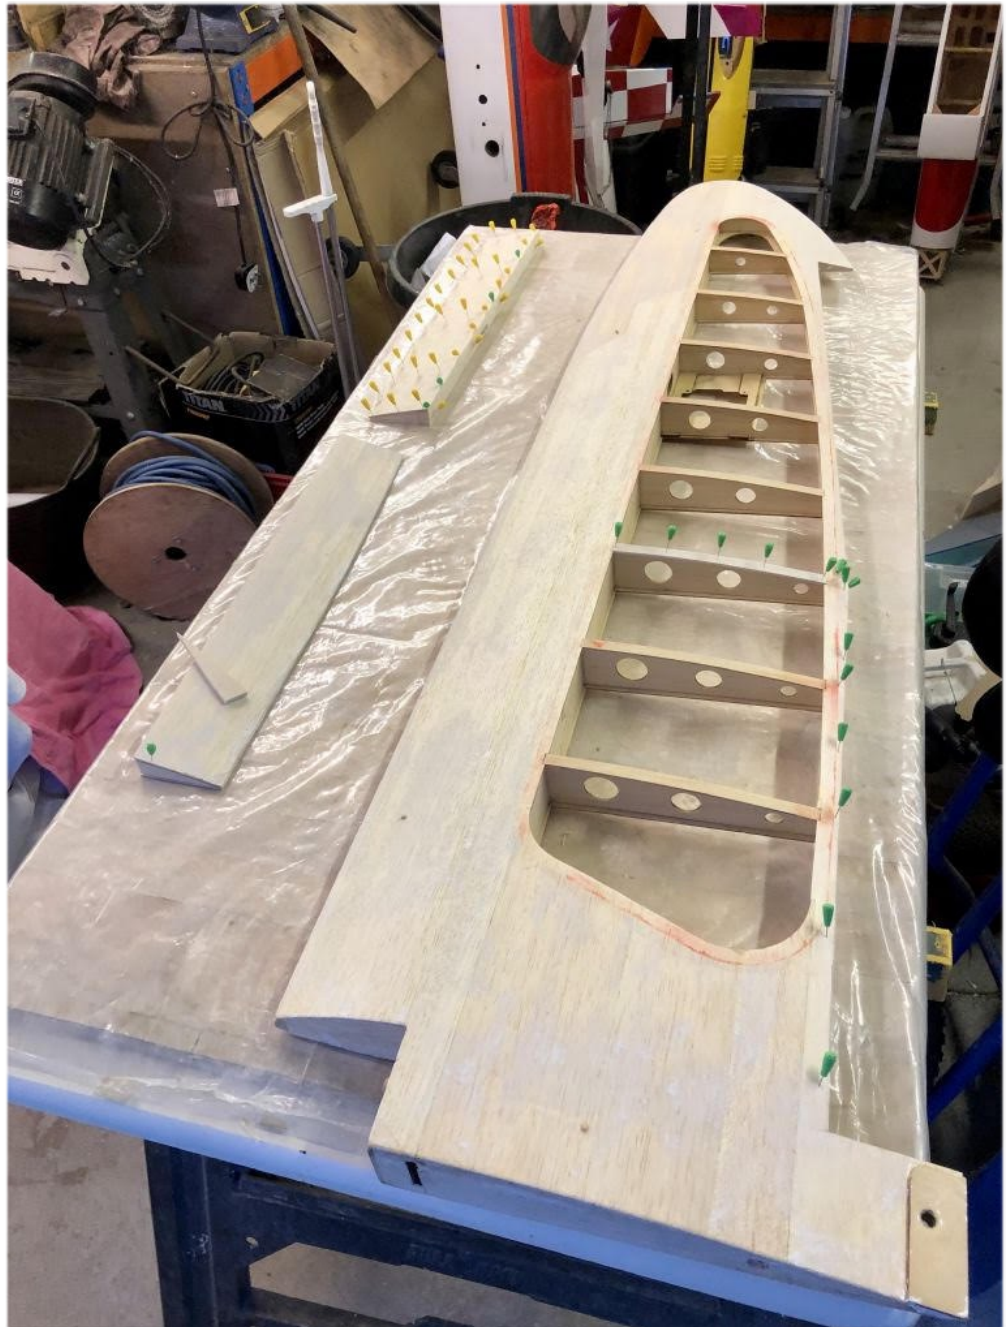
The new flap with its top sheeting added and the wing cut off ready to be converted into a flap.
